# Condition Assessment

Options for Repair or Demolition

**Mitchell Field Pier**

February 21, 2013

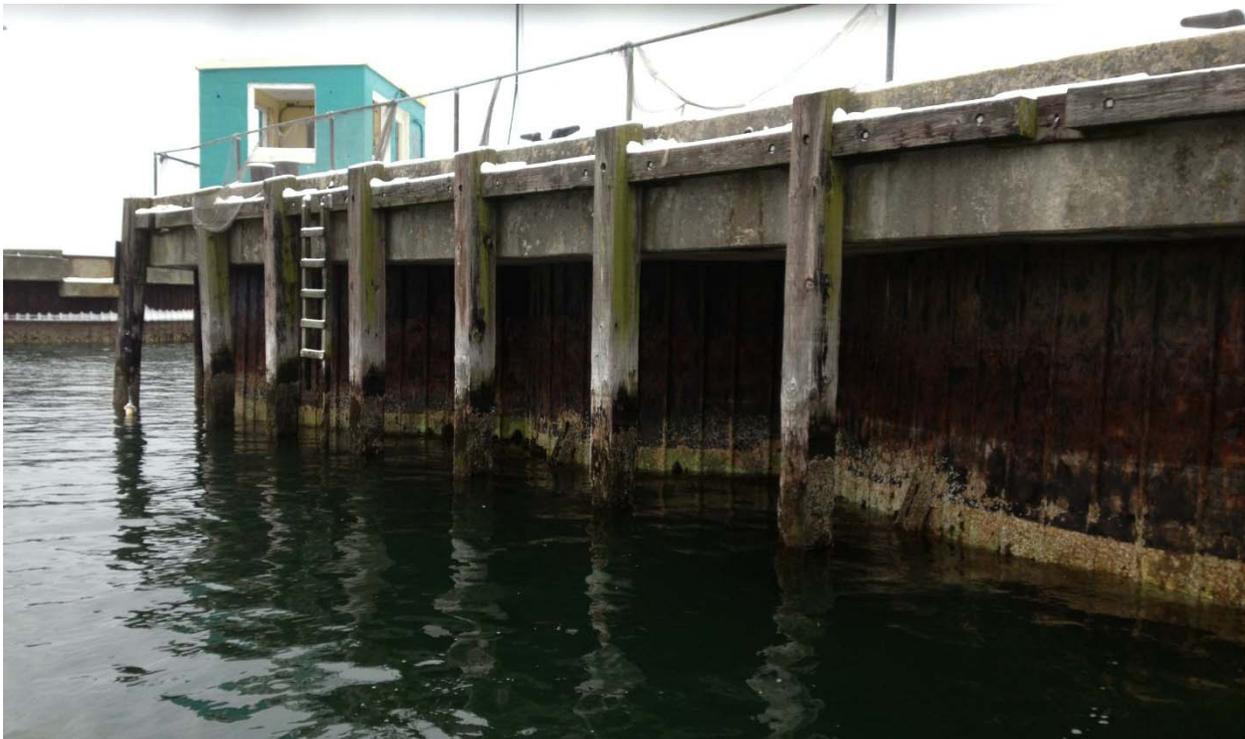
Figure 2 – Rear Face of Breasting Dolphin (Jan 2013)

The Breasting Platform is currently in very poor condition. The steel sheet pile is badly deteriorated with holes completely through in many areas. Through the holes, voids are visible within the cells indicating that some amount of material has spilled out of the cells and onto the seabed. The size of voids is unknown. Currently, there are various birds living within the voids of the cells.

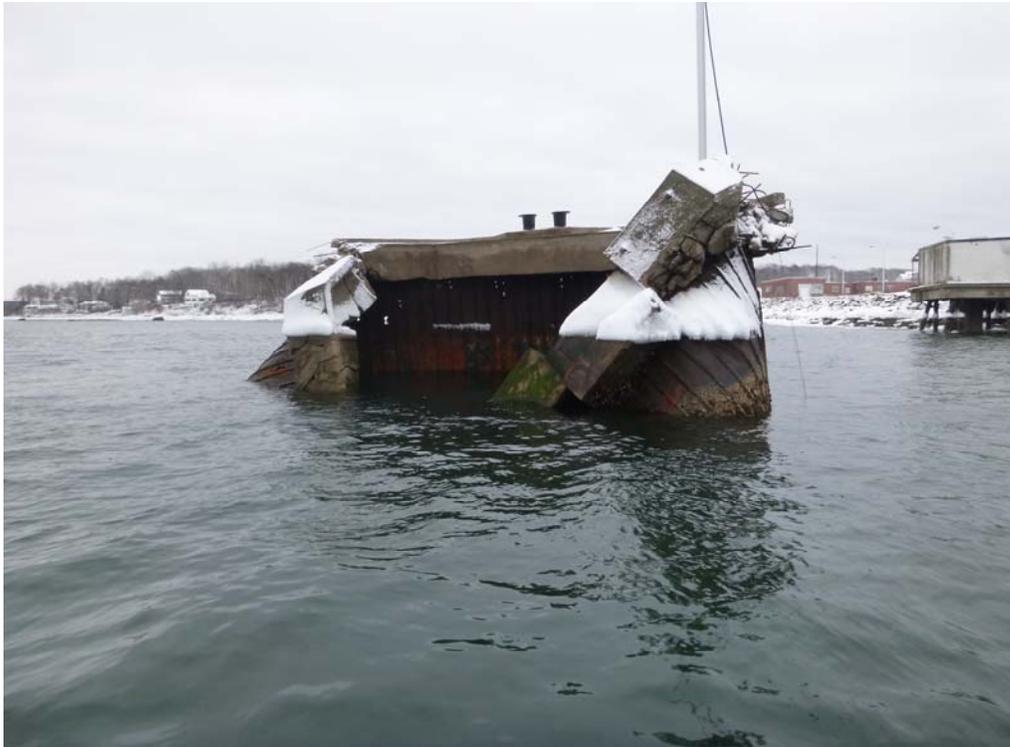
Figure 3 – Collapsed North Dolphin, January 2013

The North Mooring Dolphin failed in April 2012. The west face of the sheet pile cell split open and the reinforced concrete ring-cap fell into the inside of the cell. Original construction plans show that the cells were filled to the top with rock or gravel. While the exact sequence of events throughout the cell failure is unknown, the fact that the concrete cap and west face of the sheet pile have fallen inward suggests that a substantial amount of the original fill material has spilled out of the cell and onto the seabed. The lack of a noticeable mound of material on the seabed suggests that the loss of material has occurred over an extended period of time (allowing the material to be dispersed over a larger area by the tidal currents) and was not a sudden occurrence.

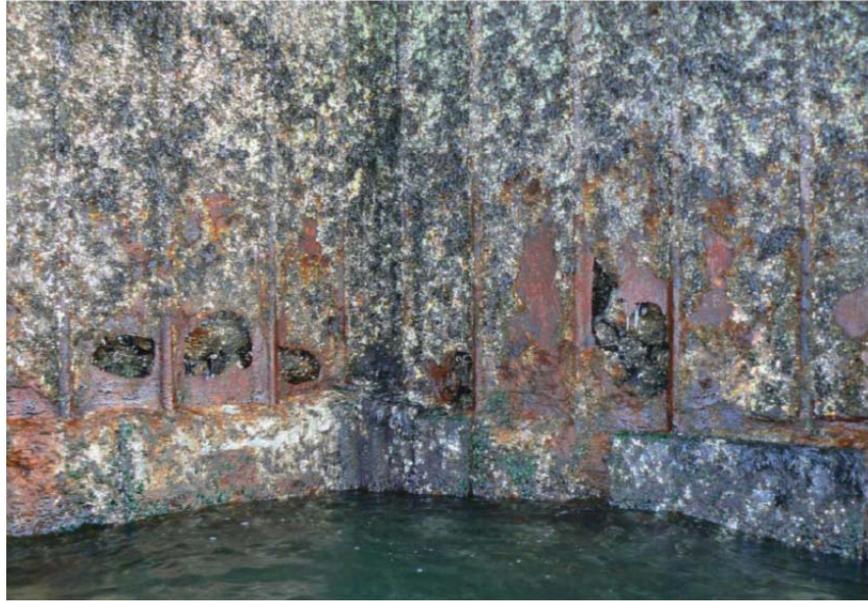
The projected levels of deterioration are provided in Table 3. The current structural condition confirms the projected deterioration levels, with the greatest levels of deterioration observed within the splash zone and within the intertidal low water zone. Examples of the corrosion levels in these areas are provided in Figure 6 and Figure 7. The continuous immersion zone is heavily coated with marine growth and the structural condition is not easily examined without disturbing this habitat. It is believed that the condition within this zone is poor, although somewhat better than in the Splash Zone and Intertidal Low Water Zone, based on the projections provided in Table 3.

Figure 6 – Corrosion within Intertidal Low Water Zone (Courtesy of TEC Associates)

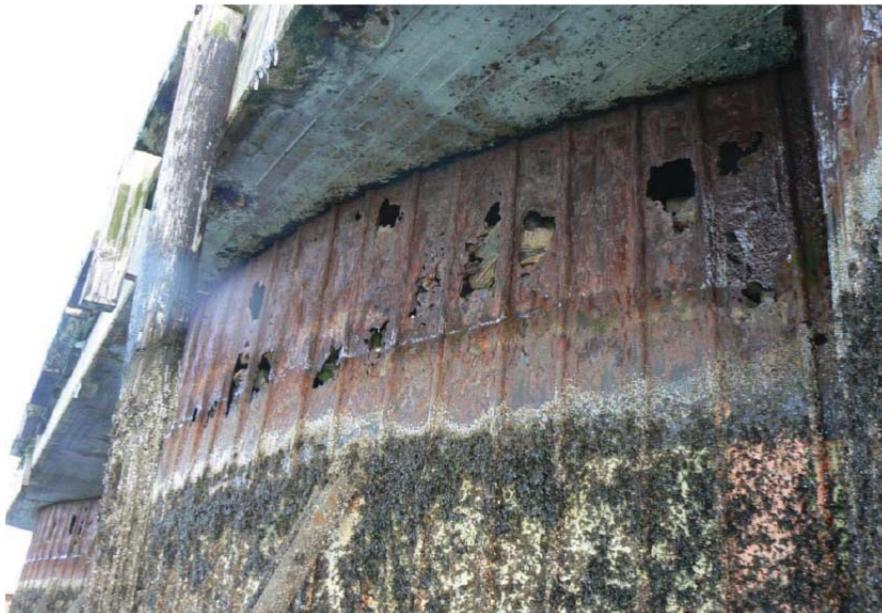
Figure 7 – Corrosion within Splash Zone (Courtesy of TEC Associates)

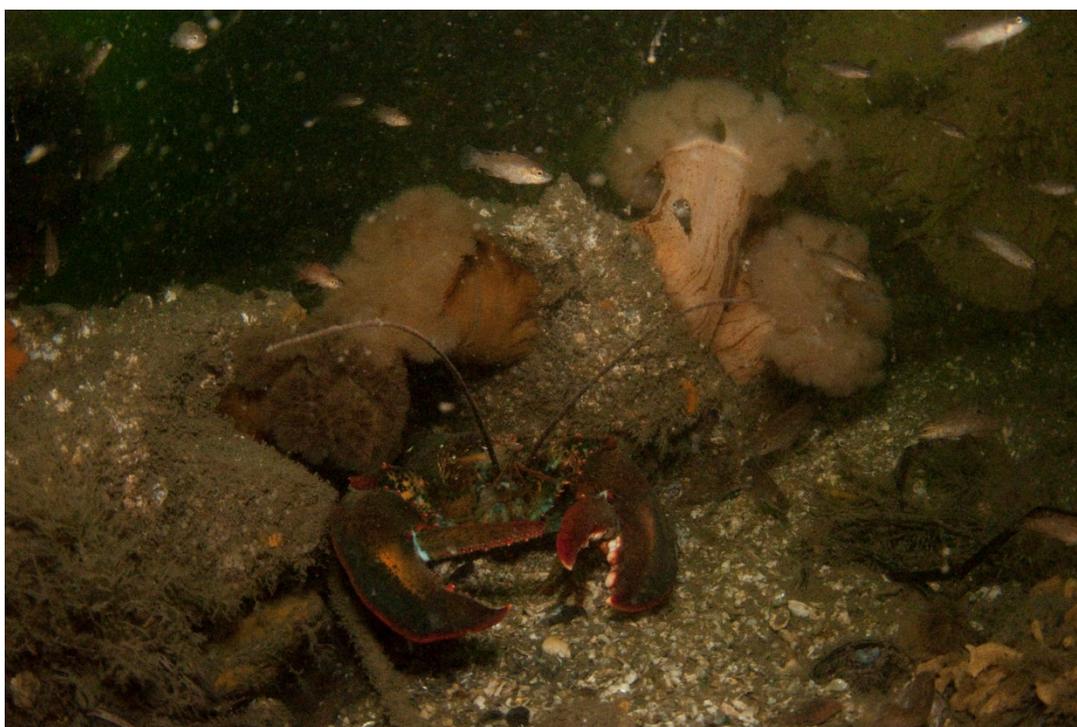
**Photo 4. Debris adjacent to wall providing complex, hard habitat**
