Mitchell Field Navy Facility Tank 100,000 Gallon Elevated Tank Condition Assessment Report

Town of Harpswell, ME

Assessment Performed July 1, 2014

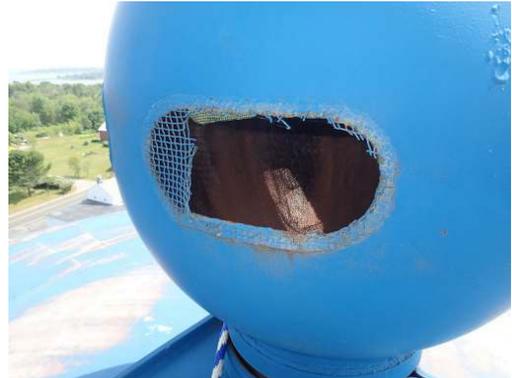
Showing a hole in the finial ball screen that should be repaired if the tank is to be returned to service.

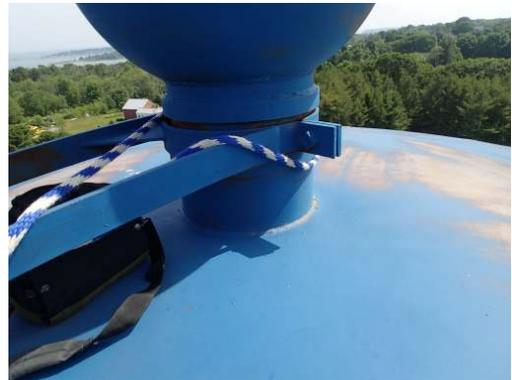
Showing corrosion on the interior of the finial ball which is open to the tank interior

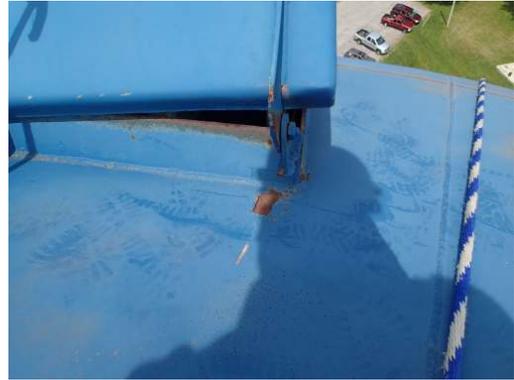
The hinges on the single 24"x24" hatch cover are broken

Showing one of two broken hatch hinges.

2. The overflow pipe opening should be equipped with a screen and flapper assembly.
3. The roof hatch cover hinges were found to be in poor condition with one broken at the welded connection to the roof and the other severely bent and damaged. The cover was removed to ground level during this inspection but should be replaced if this tank is to be returned to active service.

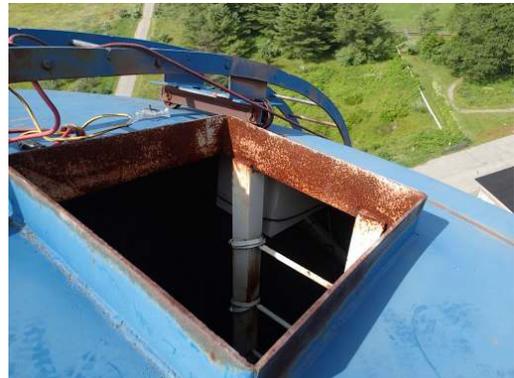
The hatch cover was removed for safety reasons due to poor structural integrity of the hinges

Extensive corrosion on the hatch neck does not appear to be affecting the structural integrity at this time

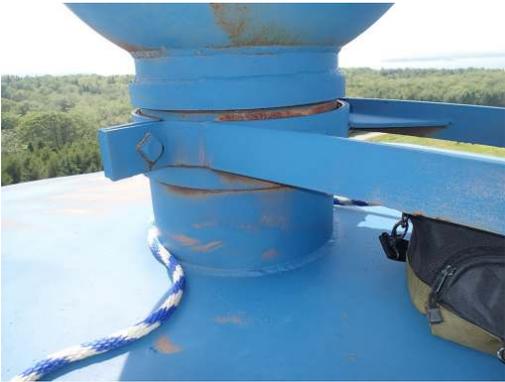
The revolving roof ladder connection bracket to the final ball neck appears in sound condition but there is corrosion on the neck surfaces

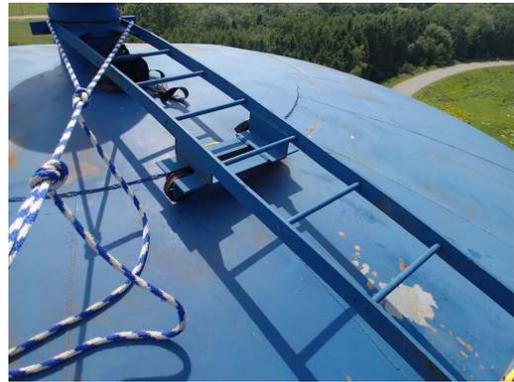
Roof revolving ladder appears in sound structural condition.

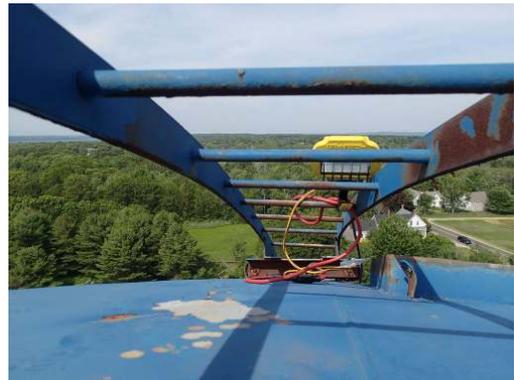
Showing corrosion of the roof ladder side rails.

Showing extensive corrosion on the ladder rungs and rails.

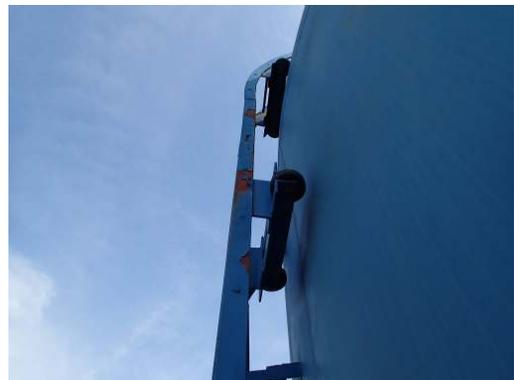
Shows medium grade corrosion on the underside of the ladder and wheel assembly.

The coatings on the revolving ladder are delaminating at the prime coat

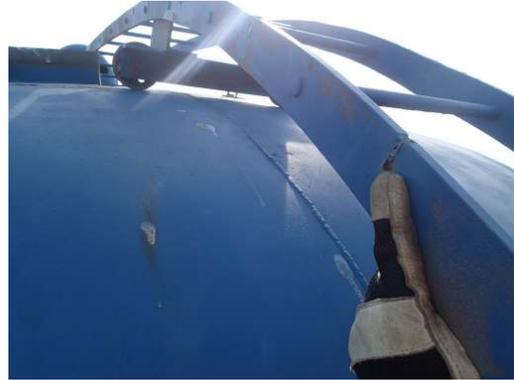
Shows medium grade corrosion where the coating has delaminated from the roof ladder siderails

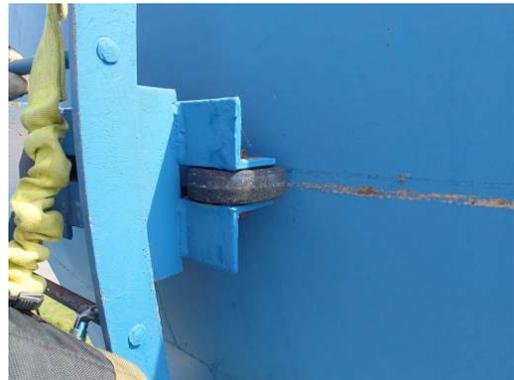
Shows abrasion damage on shell coating from the revolving ladder

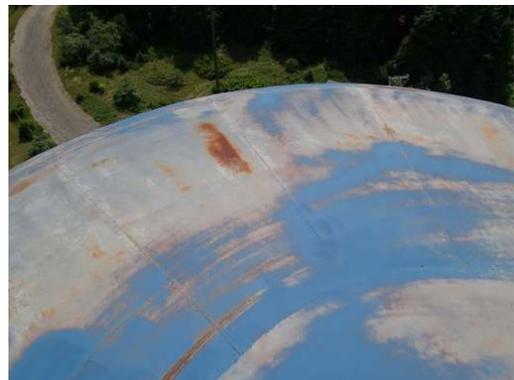
The exterior roof is in fair to poor condition with heavy weathering revealing the underlying coatings.

Roof appears in sound structural condition with only light rust and weathering noted.

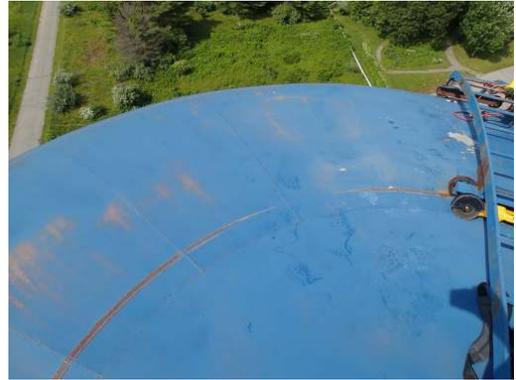
Light rust and severe weathering was observed throughout the roof plates

Shows evidence the top coat is chalked and degraded

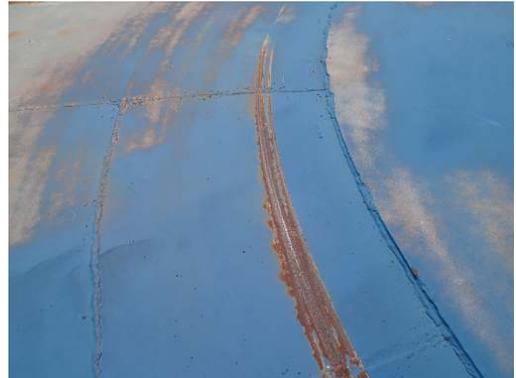
Showing weathering and abrasion damage along the center roof area

Showing abrasion damage around the center dollar plate due to the roof ladder wheels

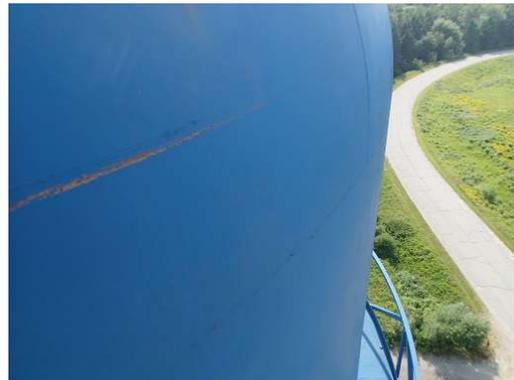
The coatings on the roof knuckle are weathered and there is evidence of abrasion damage from the revolving ladder

Showing abrasion damage from the rotating roof ladder.

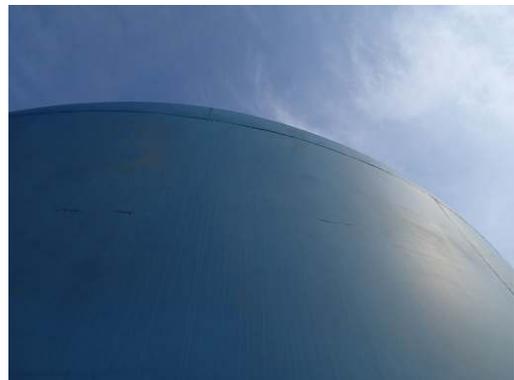
Overall view of the coatings on the roof knuckle and shell exhibiting significant weathering and areas of light rust

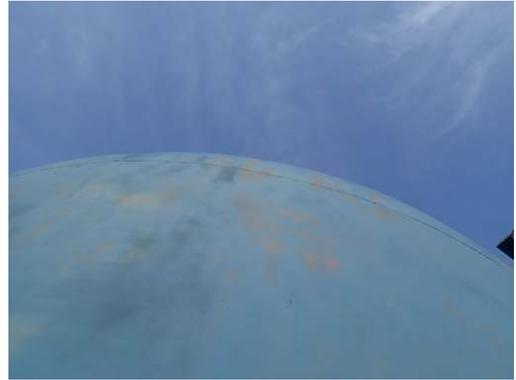
Shows light rust and soiling present on the shell plates

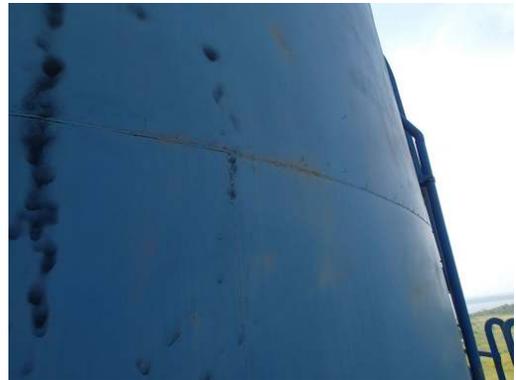
Showing graffiti on the exterior shell.

Showing light rust and weathering on the exterior shell

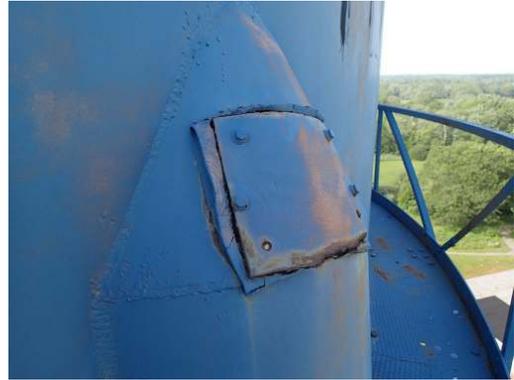
Showing wiring protruding from a pipe stub in the leg column post head at the balcony level

Showing corrosion on a cover plate installed to one of the leg column post heads

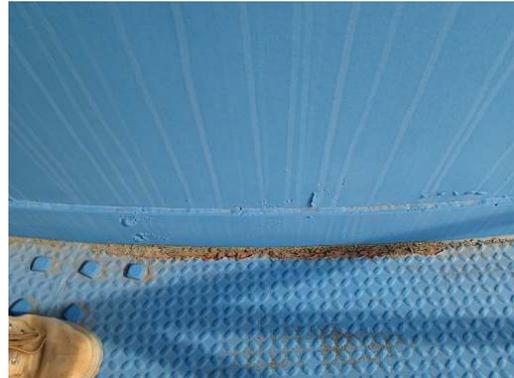
Showing heavy corrosion with possible metal loss at the shell to balcony junction

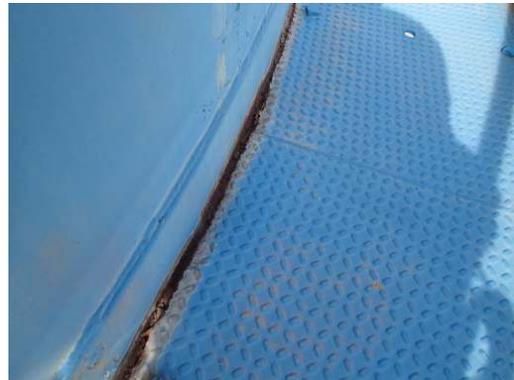
The balcony walkway are in generally good condition except for heavy corrosion along the edges.

There is heavy corrosion and slight to moderate metal loss at the balcony to shell angle junction

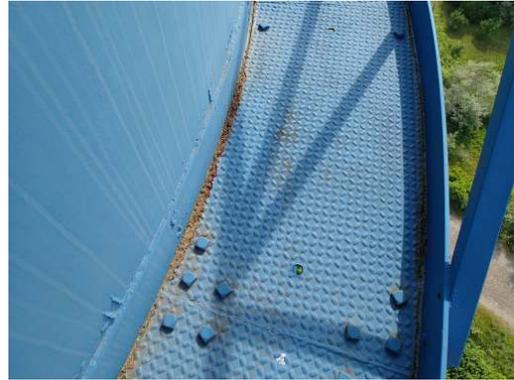
Showing a gap at the shell to balcony junction with heavy rust on the shell plate

Shows evidence of heavy rust and scale with slight to moderate metal loss of associated surfaces

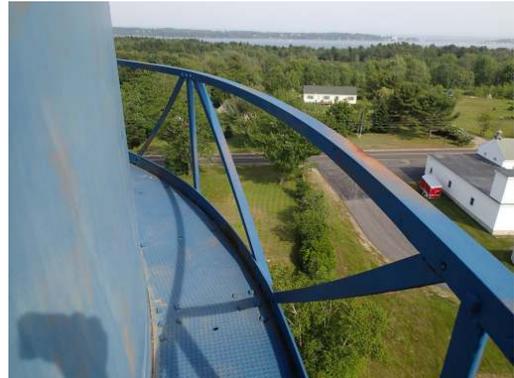
Shows scattered areas of coating failure and corrosion on the handrails.

The balcony handrails are in good structural condition although there is scattered areas of degradation

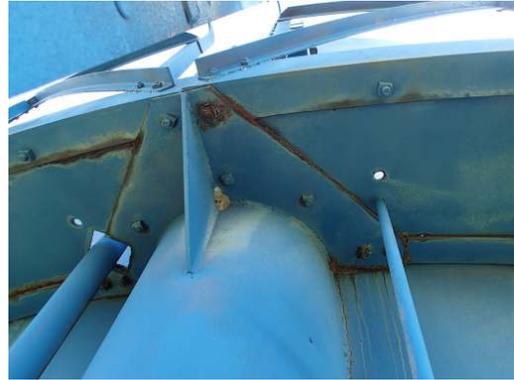
Shows an area of significant light to medium grade rust on the balcony walkway

Showing corrosion along the bolts and edges where a leg column attaches to the balcony.

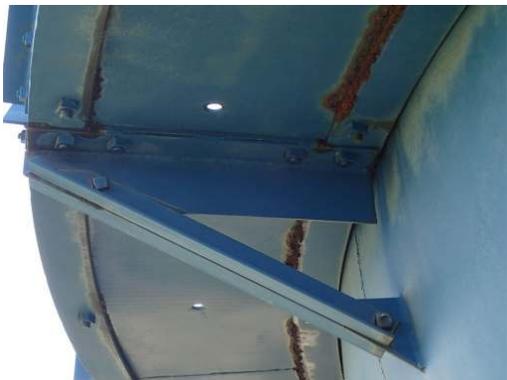
Showing corrosion and at least slight to moderate metal loss along the underside of the balcony.

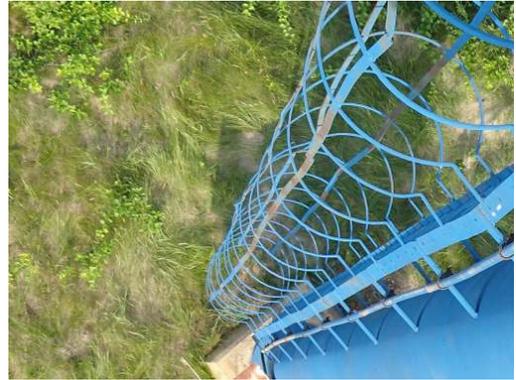
The coatings on the ladder safety cage are in only fair to poor condition

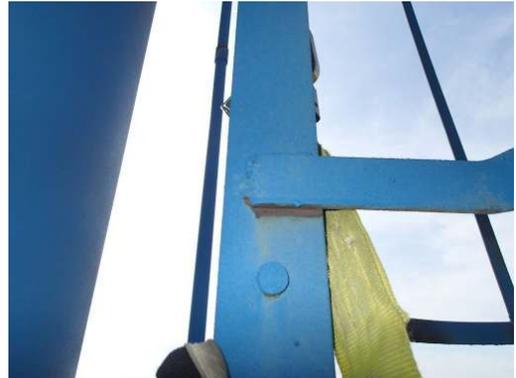
Several of the vertical ribs of the ladder cage are bent which has compromised the welds at several locations

Showing corrosion on one of the cage connections to the ladder

7. The riser foundation is in poor condition and should be resurfaced to prevent additional degradation.
8. There are several ladder cage straps that are severely bent from an unknown external force. At least one of the straps is no longer welded to the adjoining strap and therefore requires welding repairs to be performed.

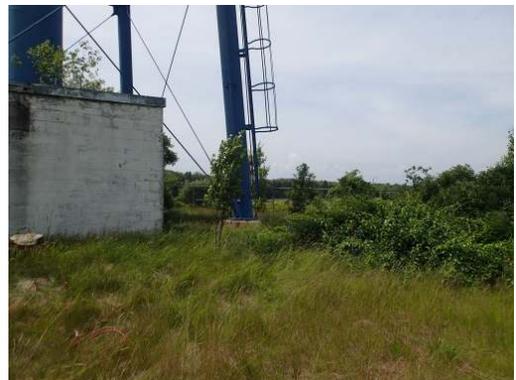
Light rust on the weld seams of several ladder to leg column brackets does not appear to be affecting the structural integrity

The leg column access ladder terminates at ground level and there is no security gate to prevent unauthorized access

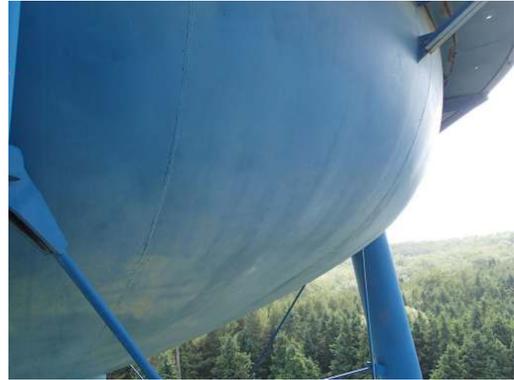
The bowl surfaces visible from the access ladder are weathered but exhibit little corrosion

Shows significant weathered coating on the bowl surfaces

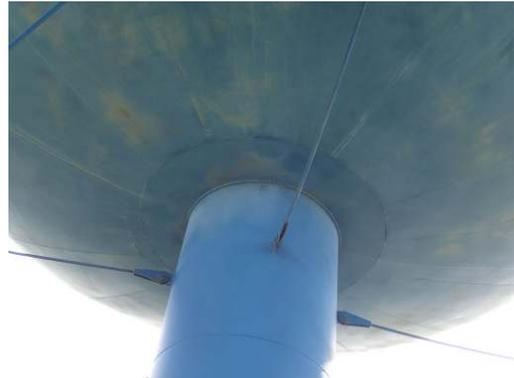
Shows significant weathered coating and scattered areas of light rust on the bowl surfaces

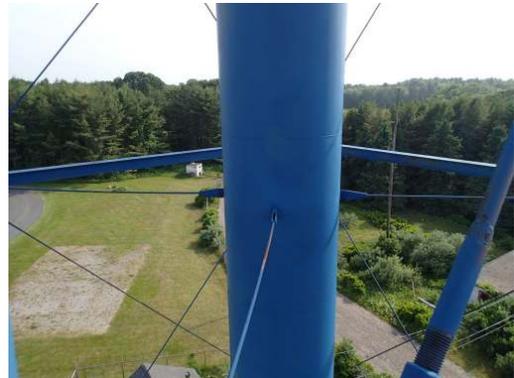
Shows rust on a riser radial rod with no evidence of any structural issues

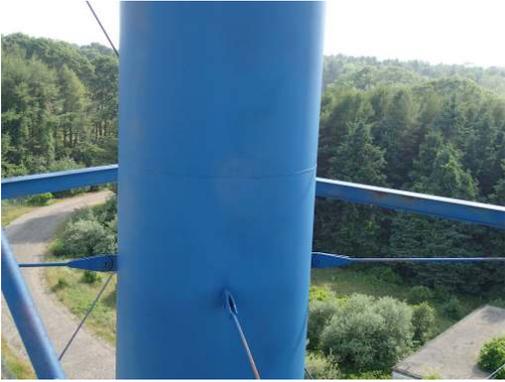
Shows areas of weathered coating on the riser

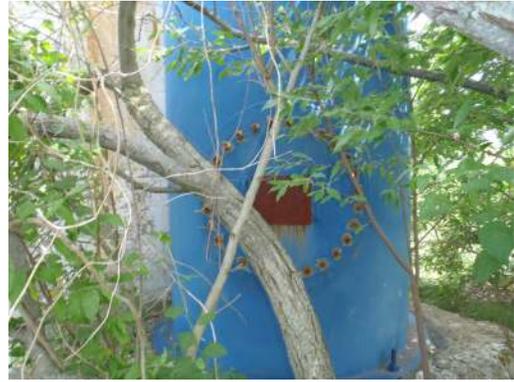
Corrosion is present on all bolted connections as well as where the tank ID plate was originally attached

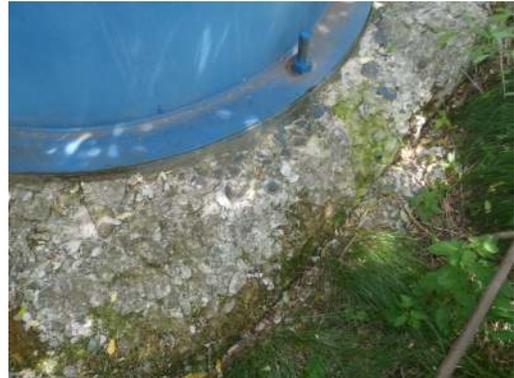
The riser foundation is in poor condition with significant degradation of the concrete exposing large aggregate

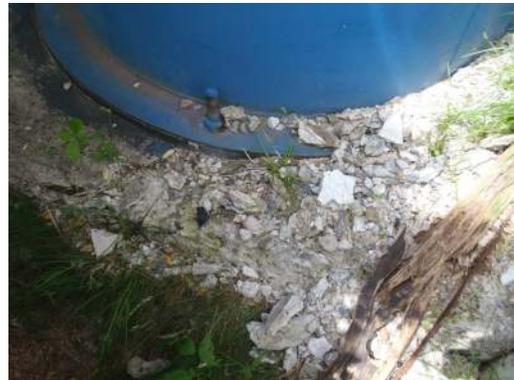
Shows concrete rubble from the degraded riser foundation

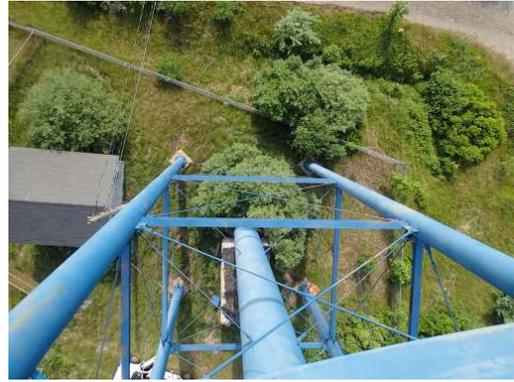
The coatings on the leg columns are weathered but exhibit little corrosion

Shows significant weathering on the leg columns

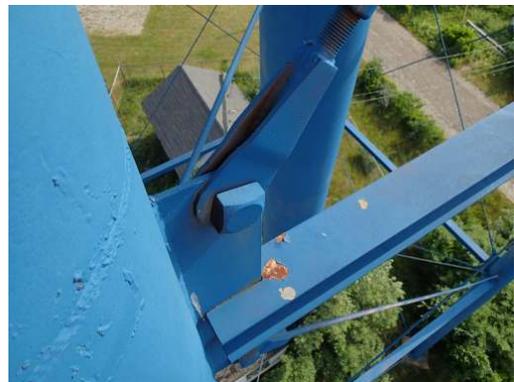
The sway rod turnbuckles are experiencing light rust but appear in good structural condition.

Showing rust on the interior of a sway rod yoke and coating delamination and surface corrosion on the adjacent strut

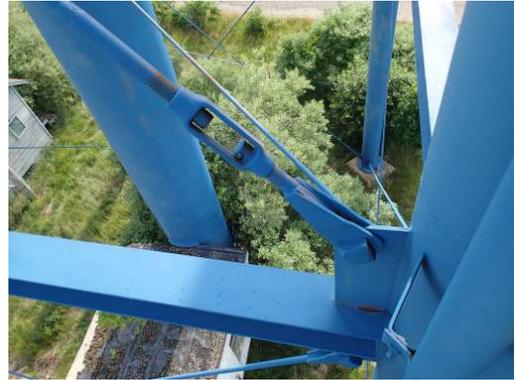
Showing localized areas of light rust on various connections to the support structure

The sway rod connections appear structurally sound but are exhibiting light rust on the threads

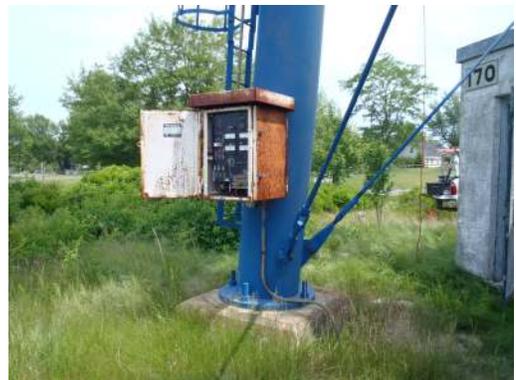
Shows what appears to be surface cracking in one of the leg column footings

5. The interior ladder connection points to the roof hatch should be reinforced with new metal to ensure the structural integrity is maintained.
6. The leg column concrete foundations are in poor condition with extensive cracking and general degradation taking place which should be repaired.

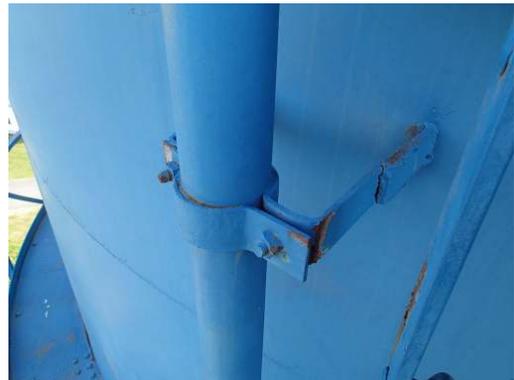
Showing corrosion on the underside of the overflow pipe and adjacent shell surfaces.

The coatings on the overflow pipe bracket above the balcony is in poor condition and there is evidence of a cracked weld

1. There is one broken overflow pipe support bracket above the balcony level, and an additional severely deteriorated bracket at ground level which is exhibiting severe metal loss and is missing a retention nut that will require repairs when this tank is next maintained. In order to ensure the structural integrity of the pipe during future overflow events, the bracket at the balcony level should be repaired and welded back into place and the bracket at ground level should be replaced in its entirety.

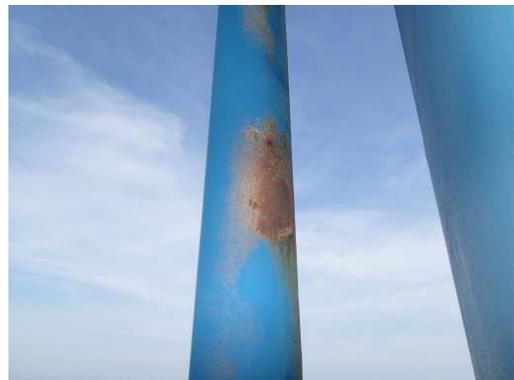
Showing a crack on the overflow pipe standoff bracket at the balcony level

Showing corrosion on the backside of the overflow pipe as viewed from the balcony

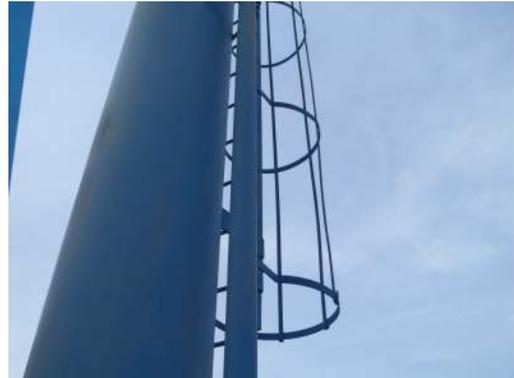
Showing corrosion occurring on the backside of the overflow pipe.

The overflow pipe coatings are in fair condition with scattered areas of corrosion mostly along the backside of the pipe

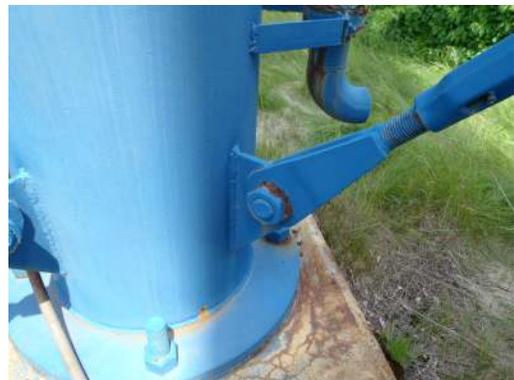
Shows heavy rust, scale and associated moderate metal loss as well as a missing nut on the lower overflow bracket

The overflow terminates approximately 20"± from grade with no evidence of a splash pad or riprap area for drainage

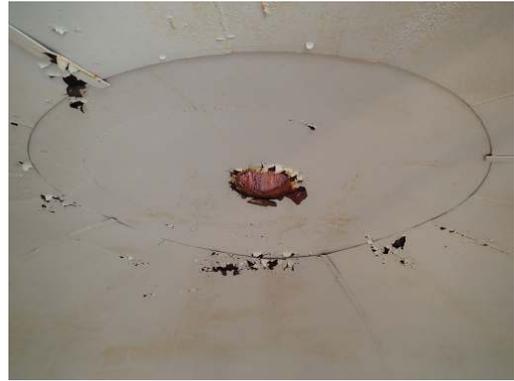
Interior roof coatings are in only fair to poor condition with areas of complete delamination to the substrate and associated medium to heavy rust as well as scattered areas

All interior surfaces of the roof, shell, bowl and riser should be abrasive blast cleaned in accordance with SSPC-SP #10 Near-White Metal standards followed by the application of (1) coat of NSF approved zinc rich urethane primer applied at 2.5 to 3.5 mils and (1) stripe coat of an NSF approved 100% solids epoxy applied to all seams from the high water level down, as well as to any heavily pitted surfaces which do not meet the criteria for spot welding repairs. All interior surfaces should then receive (1) full coat of an NSF approved 100% solids epoxy coating applied at 20.0 to 30.0 mils.

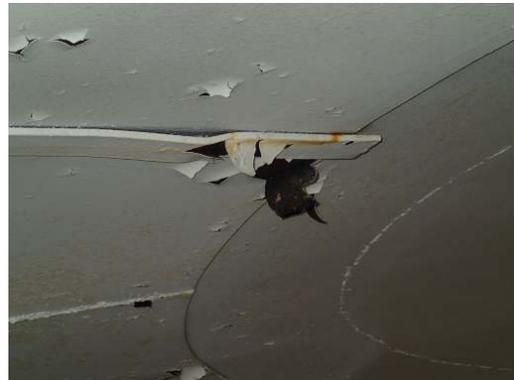
Delamination was noted along the center roof as seen near the vent opening.

Showing delamination along the roof plates and seams.

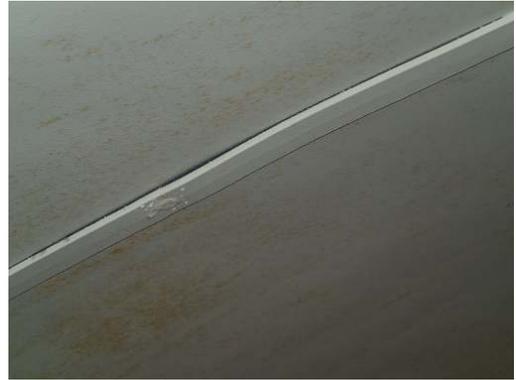
Showing delamination and corrosion along the roof plates and seams.

Showing light rust breaking thru the coatings on the underside of the roof plates.

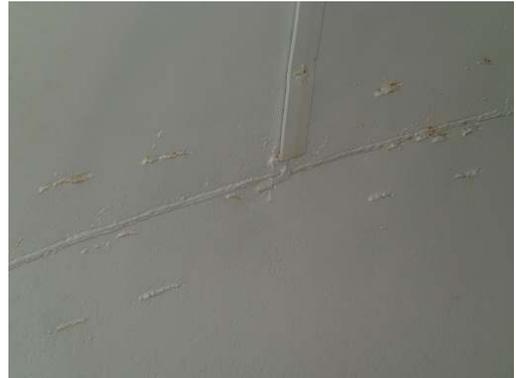
Shows backing strip in place on the underside of the roof and knuckle plates

Showing light rust on the erection burrs remaining on the knuckle and shell plates

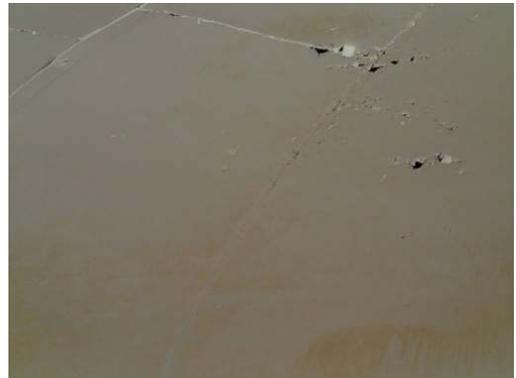
Shows corrosion under the backing straps along the roof and knuckle plates

Showing delamination along the upper roof plates and seams with additional light rust present on the lower surfaces

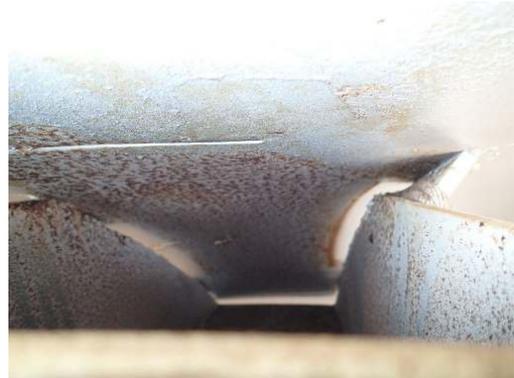
Sideview of the weir box configuration showing the box is stepped off of the roof and supported by gusset plates only with no access for painting

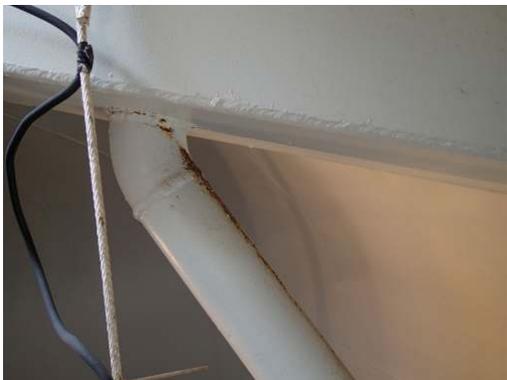
Interior view of the weir box showing corrosion along inaccessible surfaces

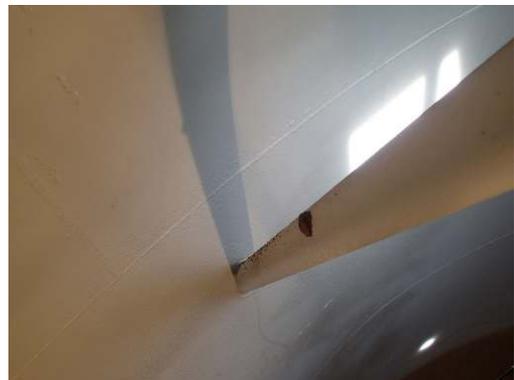
Corrosion is occurring on the internal portion of the overflow pipe.

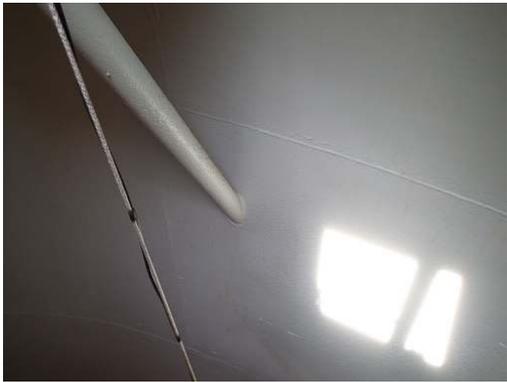
Corrosion is occurring on the internal portion of the overflow pipe.

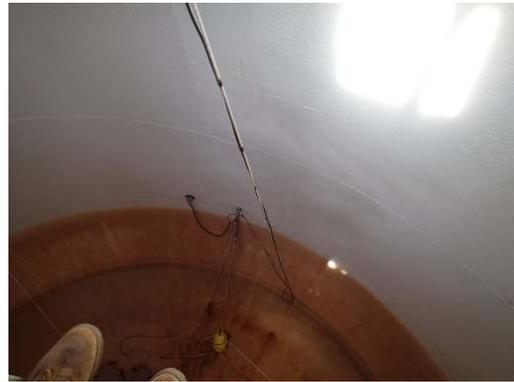
The shell coatings are in good condition and past pitting appears to be well sealed by the coating

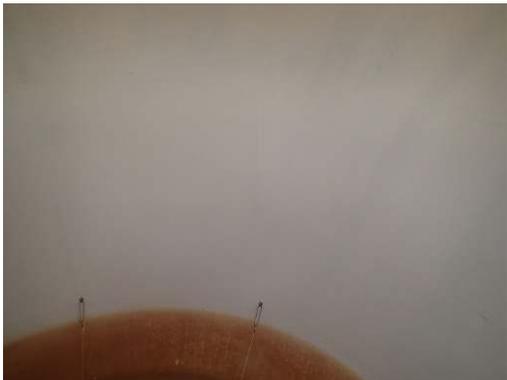
Shows past pitting on the upper shell ring which is being afforded good protection by the existing coating system

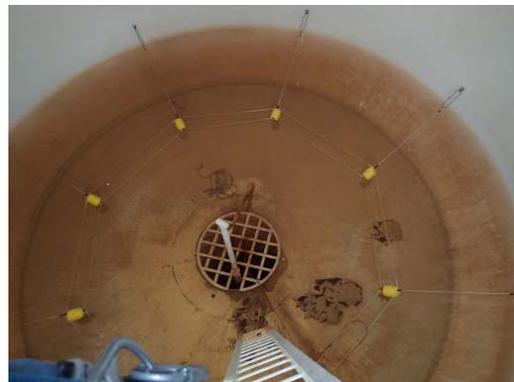
The interior bowl is stained and there appears to be three separate areas of degradation. The cathodic protection system appears intact.

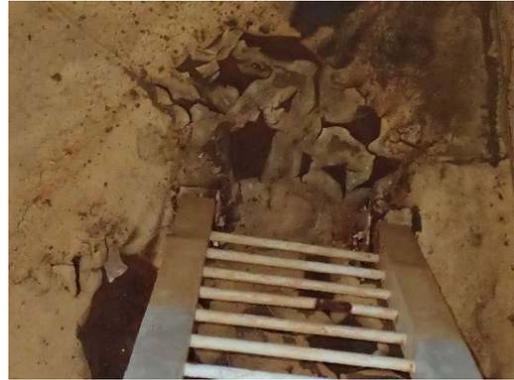
Showing an area of coating delamination and corrosion on the interior bowl.

Showing delamination of the coatings on the bowl surface at the base of the interior ladder.

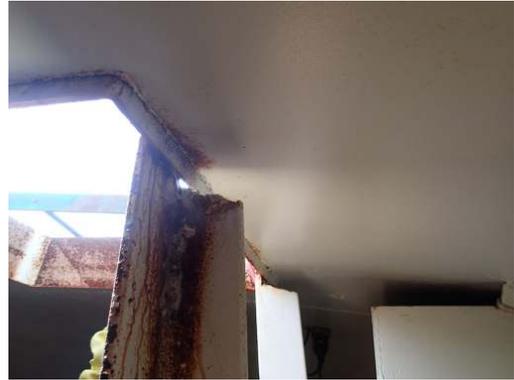
Showing corrosion on the backside of the interior ladder siderails adjacent to the roof.

The interior ladder siderails connections to the manhole neck should be extended and reinforced during future maintenance

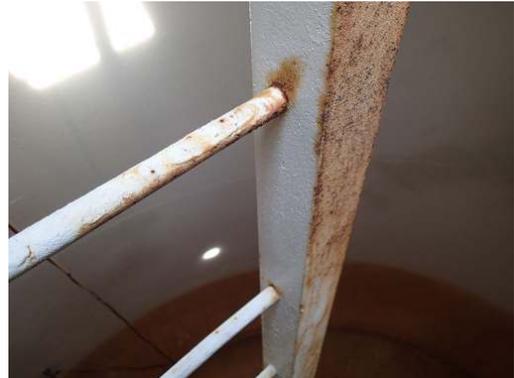
The interior ladder appears in sound structural sound condition but there is significant corrosion along the rungs and rails. There are no mid point stabilizers.

Closeup of corrosion on the interior ladder.
