# **New Meadows River Lower Watershed Survey Report**

**Prepared by  
Cumberland County Soil and Water Conservation District  
Maine Department of Environmental Protection  
New Meadows River Watershed Project**

**March 2003**

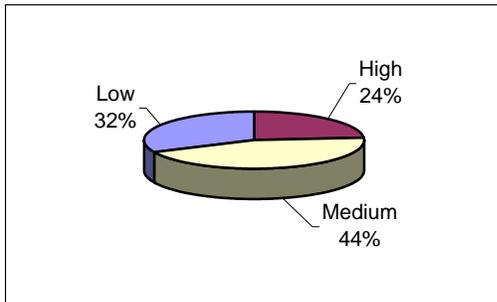
### Potential Impact of Problems

There were similar numbers of sites with low, medium and high impacts. Attention should be paid to all of the sites, since it’s the cumulative impact of **all** the sites that causes water quality to decline.

- Low—eroding site with limited transport off site, or small site with no evidence of rills or gullies
- Medium—sediment transported off site but does not reach high magnitude
- High—large area with significant erosion and direct flow to stream, ditch or river

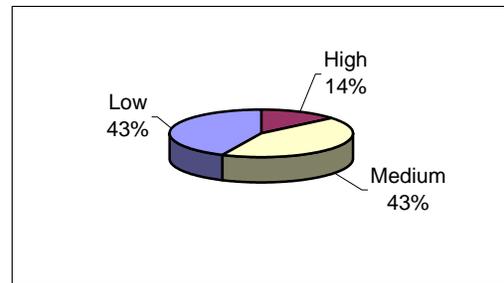
### Technical Level Needed to Correct Problem

- Low—property owner can accomplish the fix with or without proper reference materials
- Medium—technical person should visit the site & make recommendations
- High—site requires an engineered design

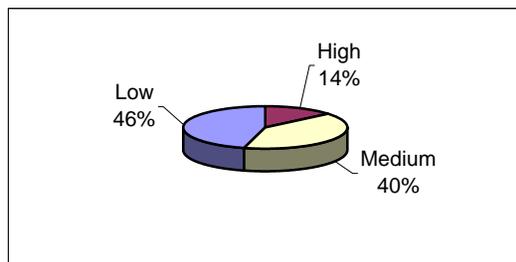
### Cost to Implement Recommendations

- Low—less than \$500
- Medium—\$500 to \$2,500
- High—more than \$2,500

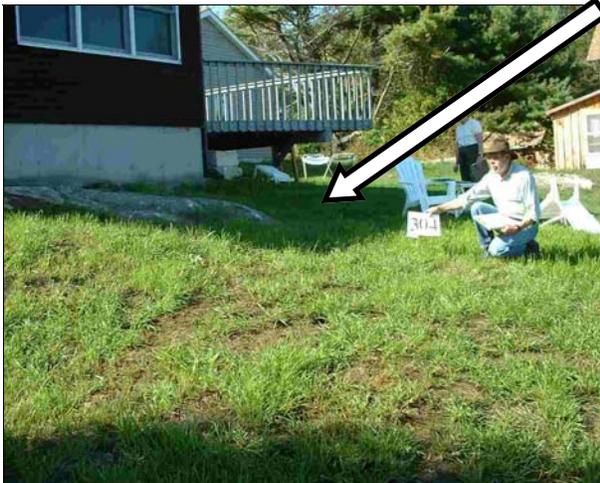
### Problems:

- Runoff from roof causing moderate surface erosion
- Patchy bare soil with direct flow to River
- Lack of vegetated buffer on shoreline

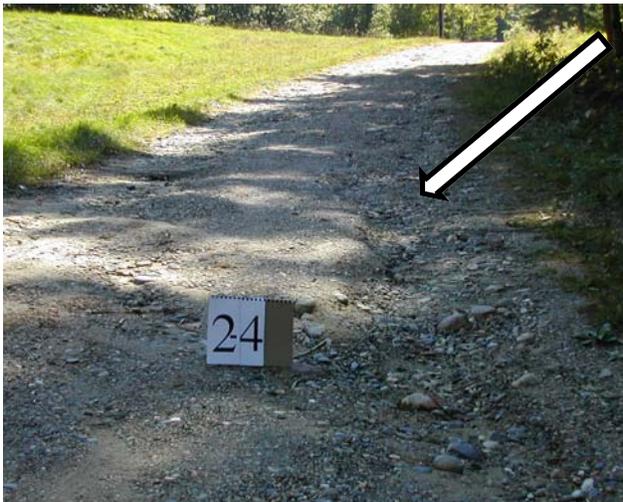
### Problems

- Moderate surface erosion
- Poor driveway shaping and ruts cause water to concentrate and erode the surface
- Direct flow of sediment to New Meadows River

**Preserve water quality and save time, money, and wear and tear on your vehicle by having a well crowned driveway. Use adequate surface material and add diversions to direct runoff into vegetated buffers.**

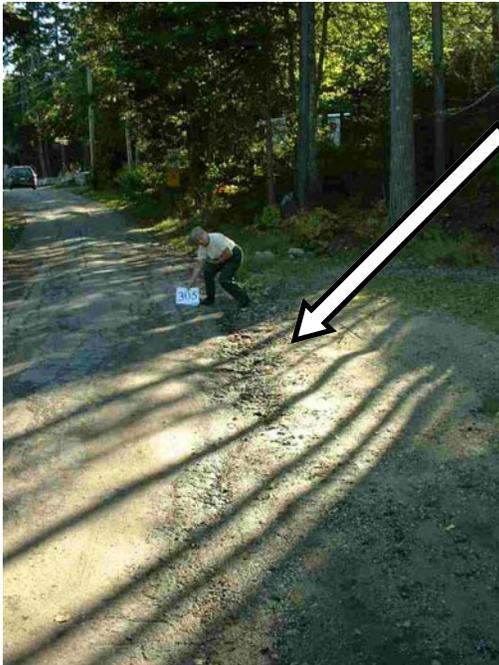
### Problems:

- Moderate road shoulder and surface erosion
- Clogged culvert
- Lack of ditch
- Direct stormwater flow to New Meadows River

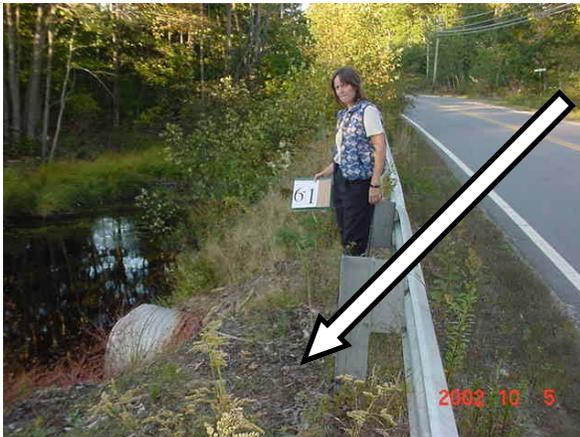
**Town and state roads sites identified in this watershed survey tended to discharge sediment directly to the New Meadows River or tributaries.**

### Solutions:

- Vegetate road shoulder
- Stabilize and maintain culvert inlet/outlet
- Reroute stormwater from road shoulder to buffer on either side of culvert with ditching

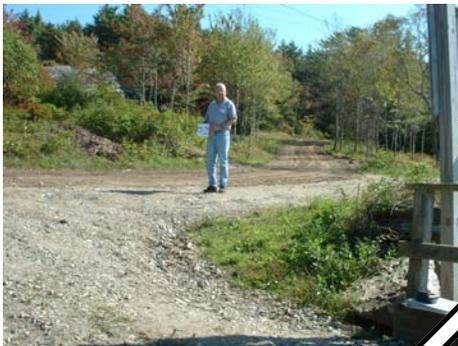
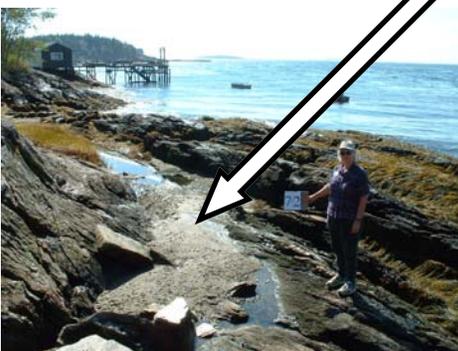
### Problems:

- Severe surface erosion on road
- Severe ditch erosion
- Direct flow of runoff and sediment to New Meadows River

### Solutions:

- Use a more cohesive/less erodable surface material
- Install waterbars to divert runoff into wooded areas
- Regrade the road away from the water to encourage infiltration in established buffer.

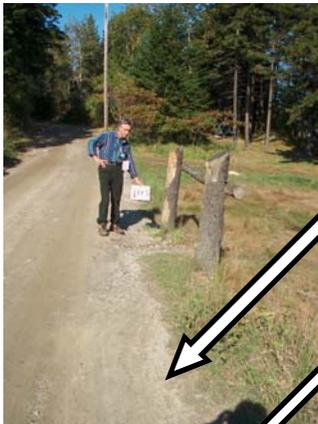
### Problems:

- Moderate road surface erosion
- Runoff and sediment travel directly into cove
- Erosion occurring around culvert outlet

### Solutions:

- Add new surface material and grade away from the cove
- Install runoff diverters, such as waterbars or open top culvert
- Stabilize culvert inlet/outlet
- Add vegetation with strong/extensive root system to hold soil in place

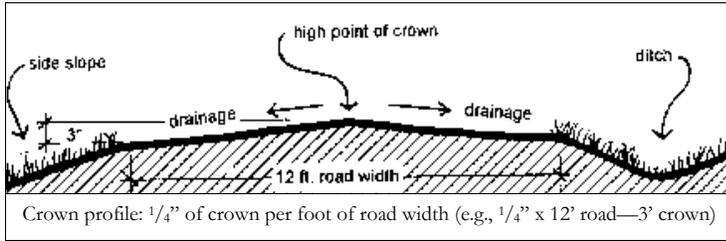
**Crown**—High point that runs lengthwise along the center of a camp road or driveway. The high point slopes gently away from the center toward the outer edge of the road, allowing water to drain off the road and preventing erosion of the road surface.

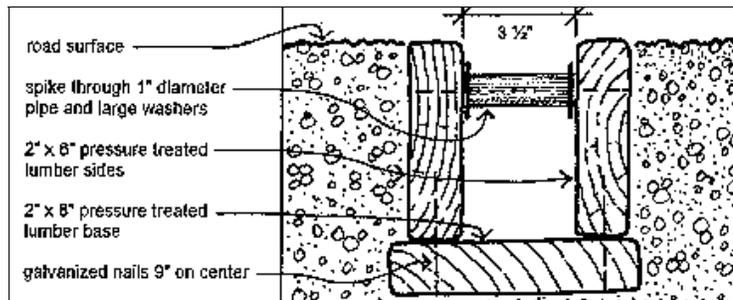
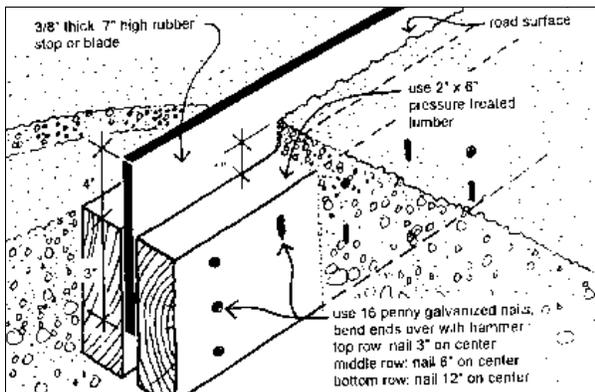
**Open Top Culvert**—Box-like structure that collects and diverts road surface runoff away from a sloped driveway or camp road. They are seldom recommended for year-round roads due to the likelihood of plow damage. Install at a 30° angle to the road and direct the outlet into a stable buffer. Clean out leaves and debris periodically.

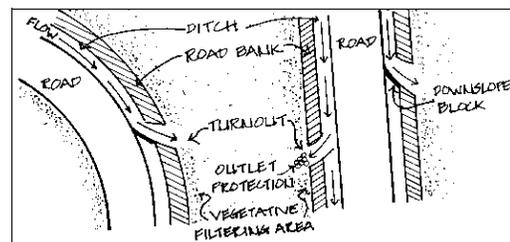
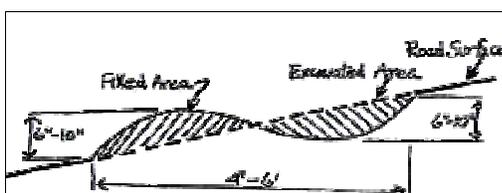
**Turnout**—A conservation practice used to direct runoff from a ditch (or road ruts) into a vegetated buffer. The turnout should have a flared end section that is level and lined with rock to spread out the flow.
