# Condition Assessment

Options for Repair or Demolition

**Mitchell Field Pier**

February 21, 2013

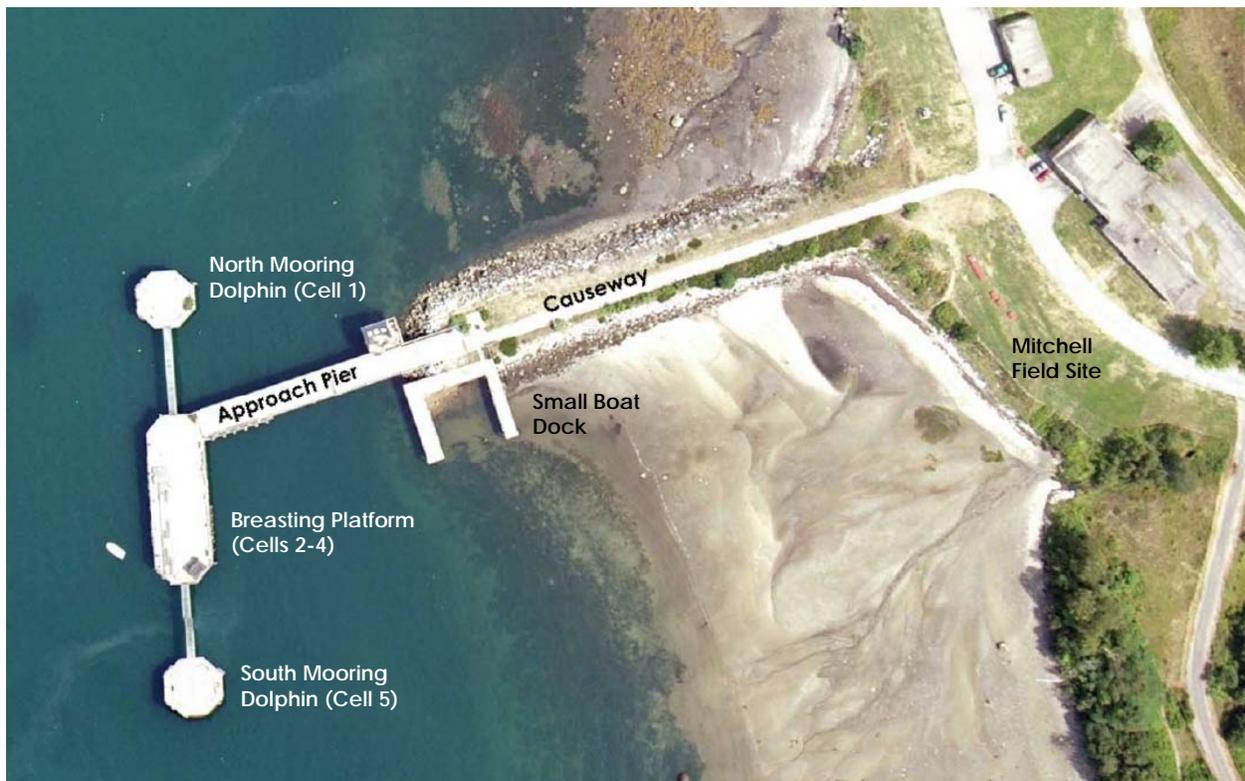
Figure 1 – Mitchell Field Pier Aerial View

The pier (see Figure 1) comprises an armored Causeway that extends from shore to low water, a 250-ft steel pile supported Approach Pier, a central Breasting Platform comprised of multiple stone ballasted steel sheet pile cells, and North and South Mooring Dolphins each comprised of a single circular filled steel sheet pile cell. The North and South Mooring Dolphins are accessed from the Breasting Platform by steel Catwalks. A small boat dock also exists near the shore on the south side of the pier that reportedly provided a station for a small support vessel that was used to surround the docking tanker barge or ship with a spill containment boom.

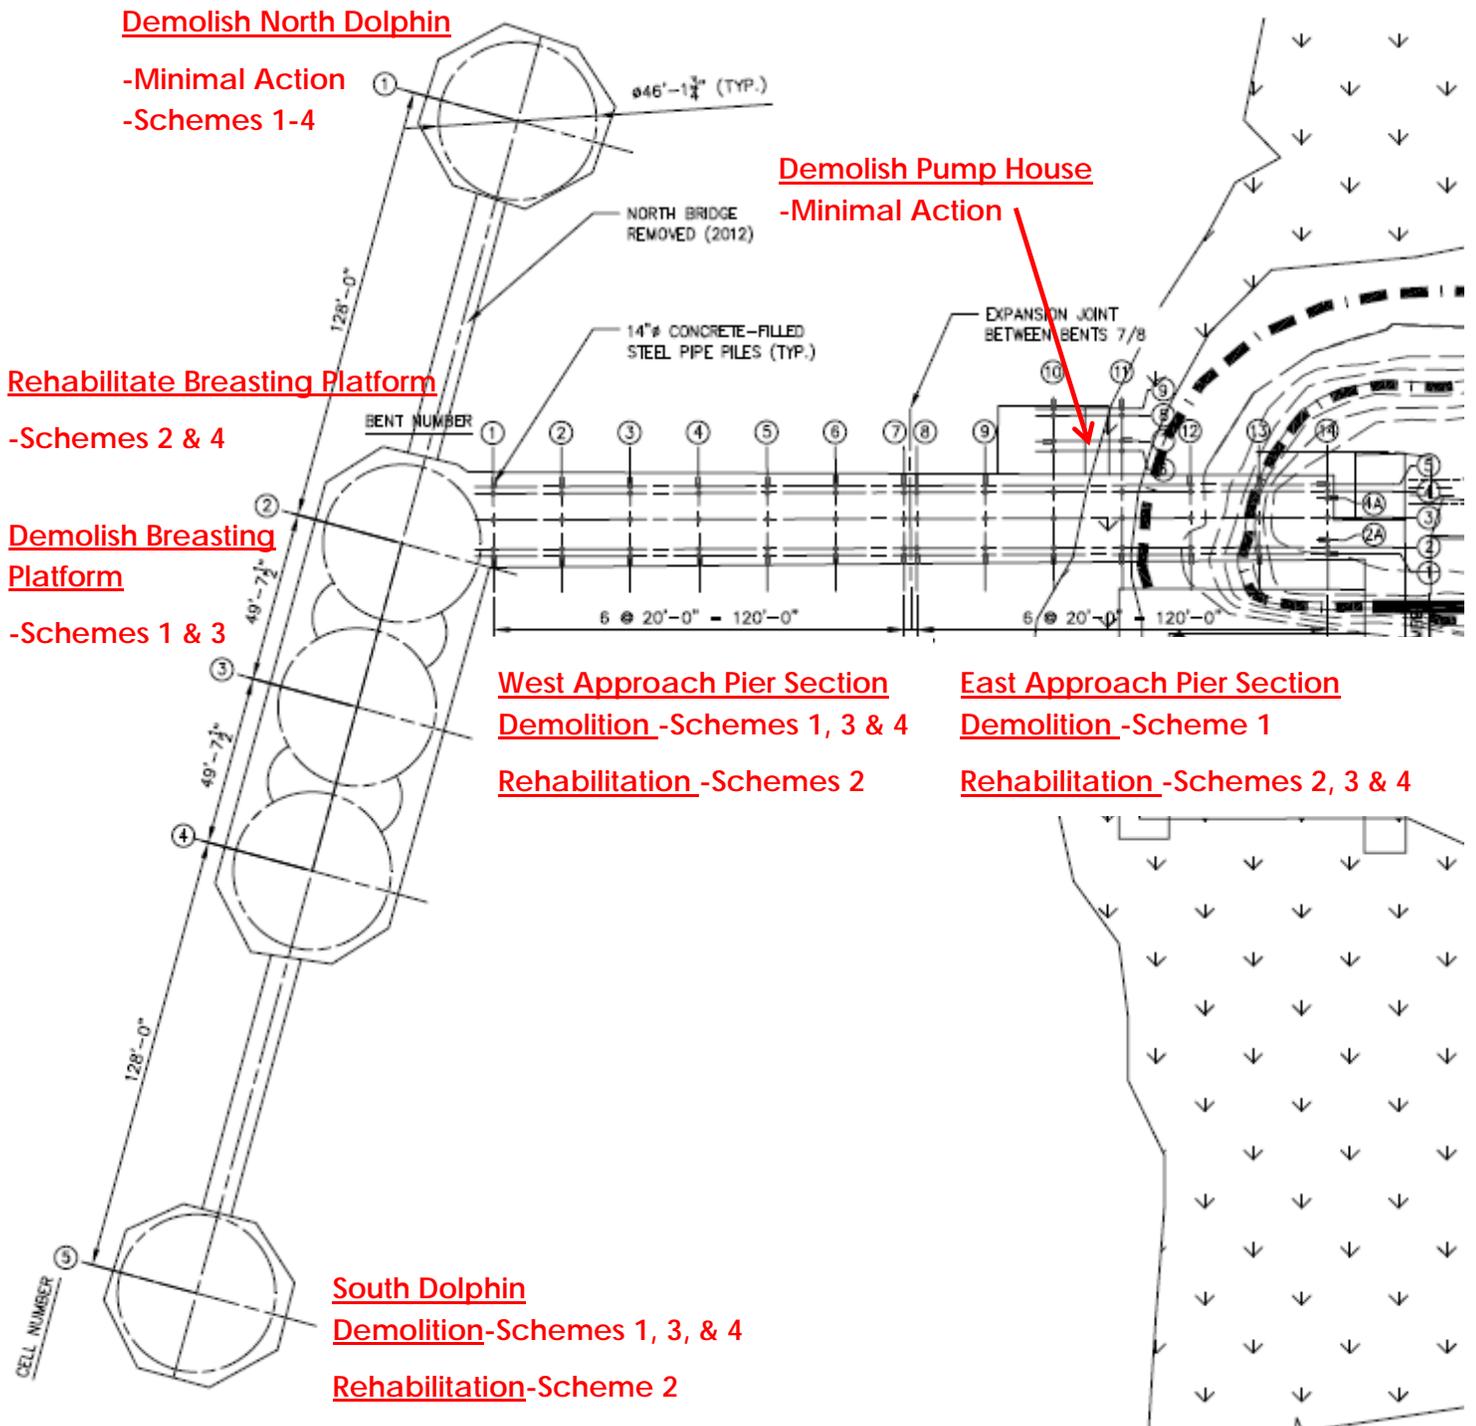
Figure 4 - Demolition and Repair Schemes

Several options to address pier condition are explored that include **Do Nothing, Full Demolition, Full Rehabilitation** and **Partial Rehabilitation**. Refer to Figure 4. A tabulated summary, together with probable cost and benefits of each option is provided at the end of this section (See Table 1).

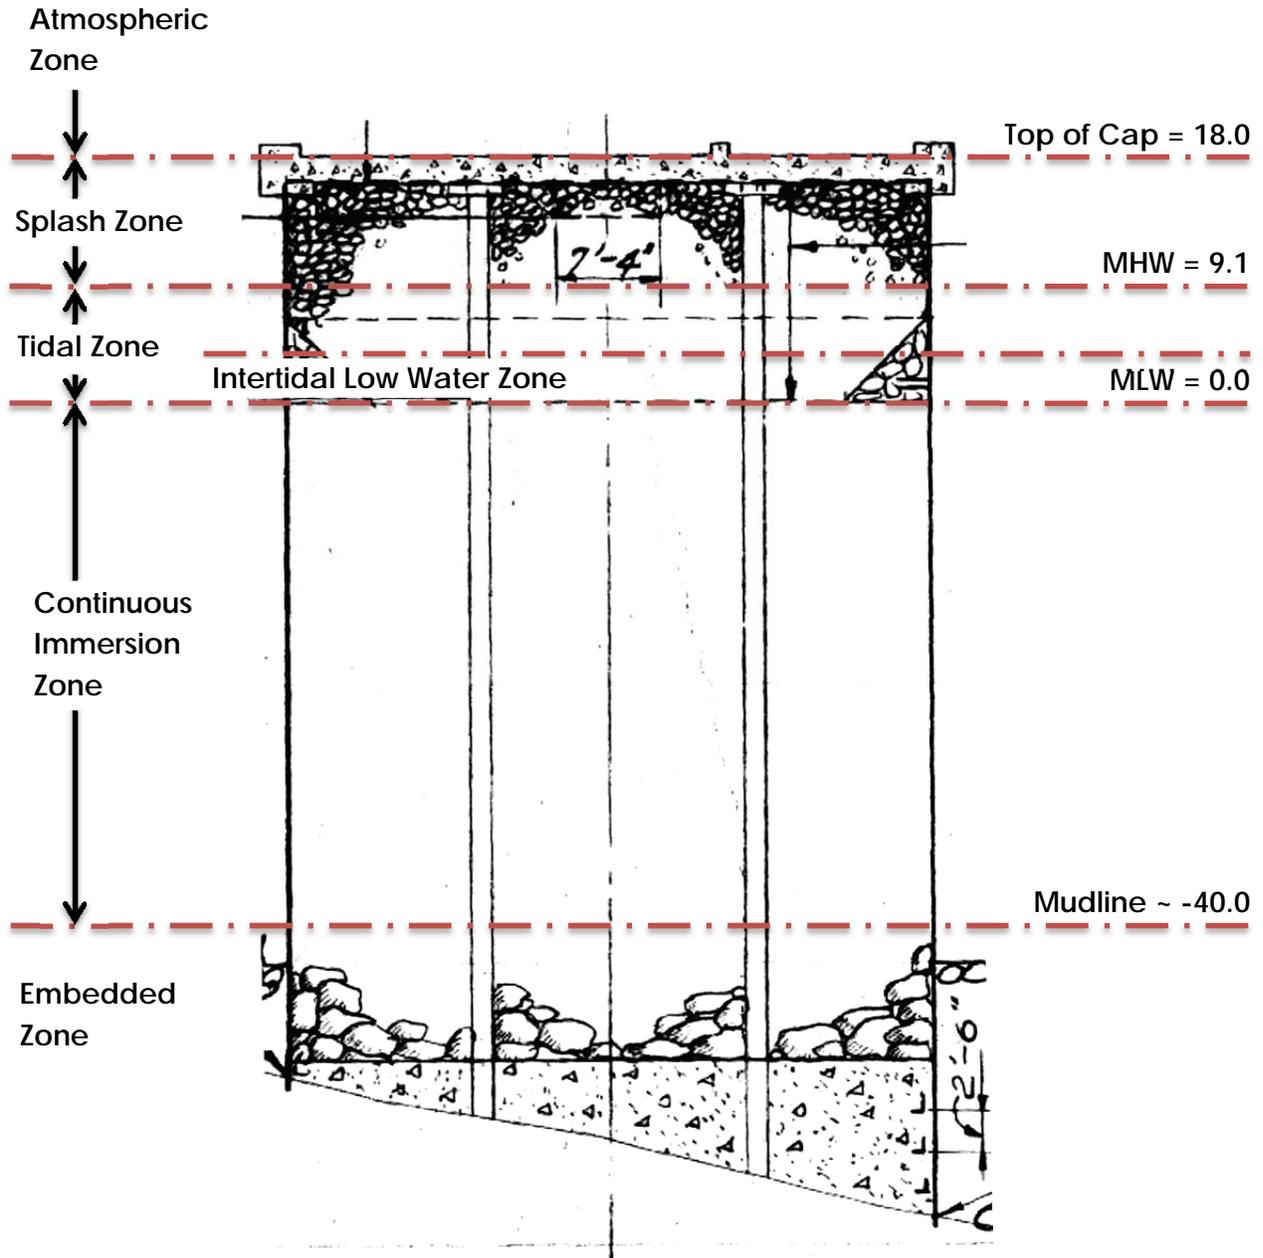
Figure 5 - Cell Corrosion Zones

These exposure zones are demonstrated for the typical pier cell in Figure 5.

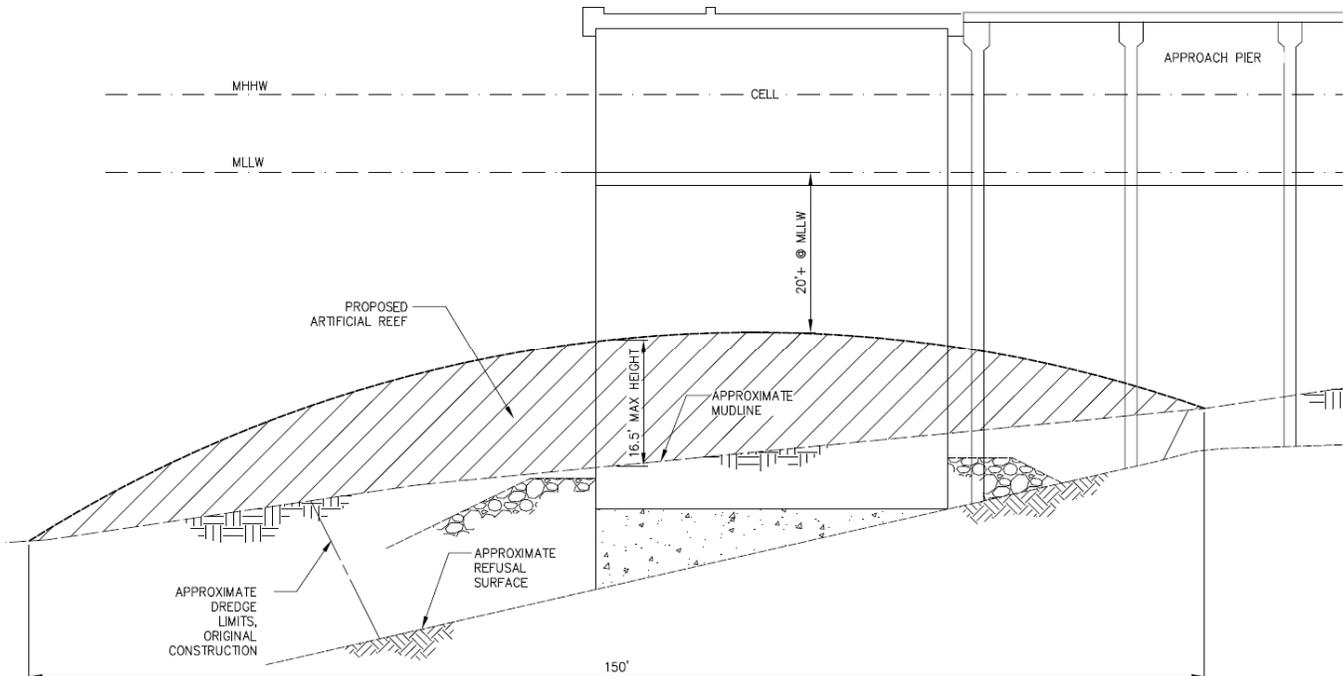
Figure 8 – Reef Building with Construction Debris

The concept of reef construction is demonstrated in Figure 8 and Figure 9, which provide a cross section for the reef utilizing 100% of the cell fill material, and the approximate footprint of the artificial reef, respectively.

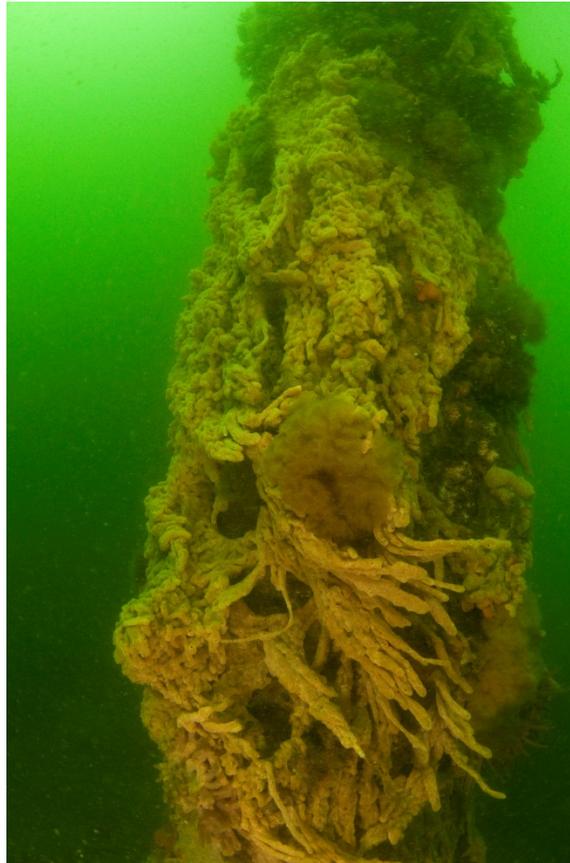
**Photo 1. Mitchell Field piling**

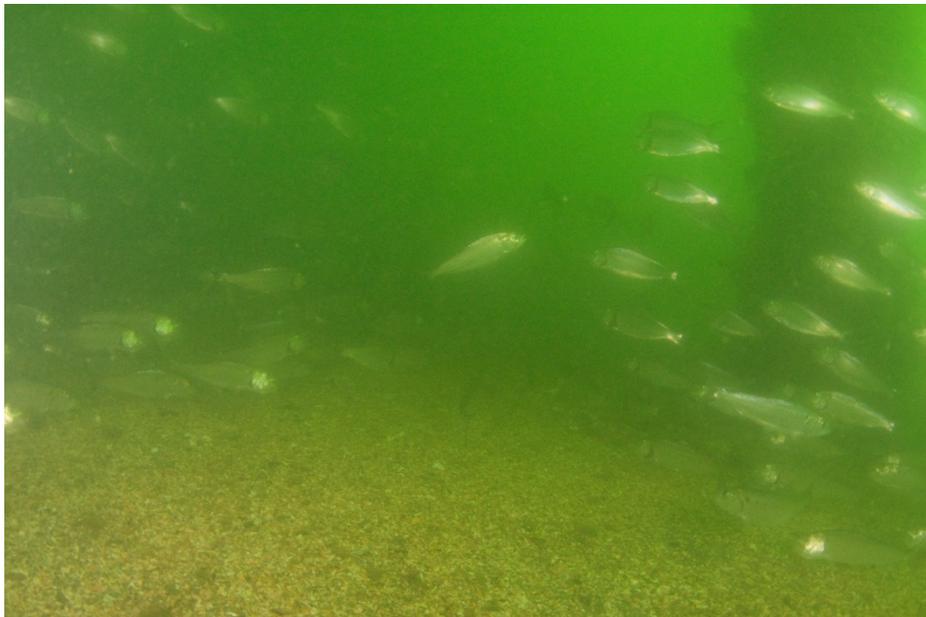
**Photo 2. Blueback herring school around pilings at Mitchell Field pier**

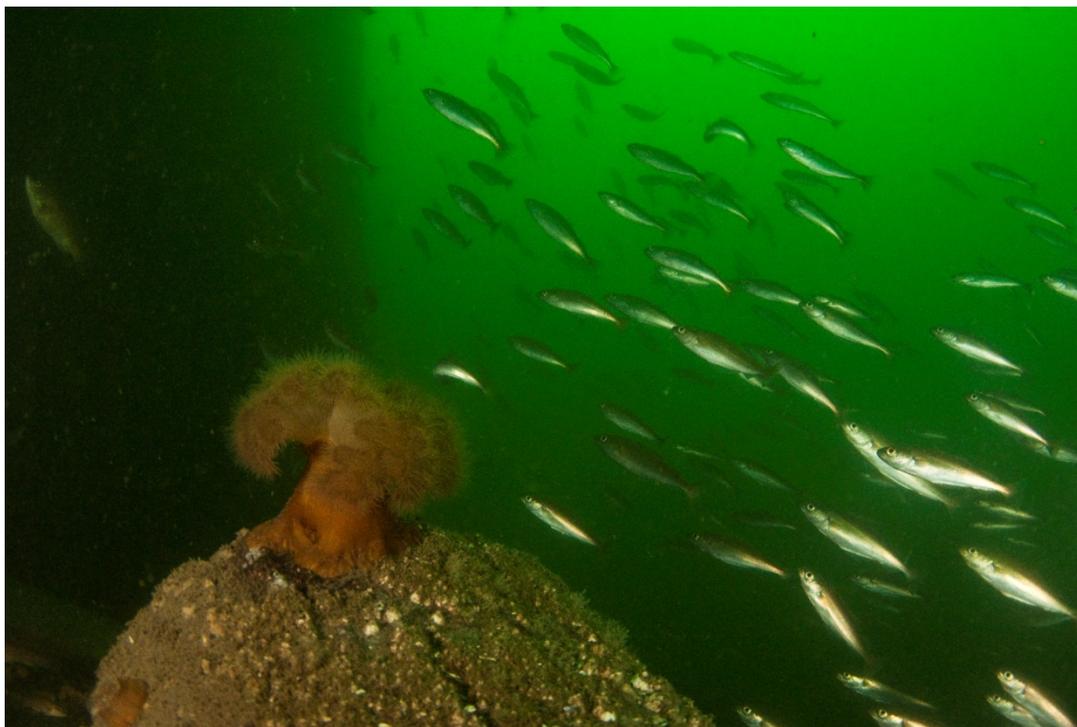
**Photo 3. School of Atlantic pollock adjacent to pilings and pier wall**

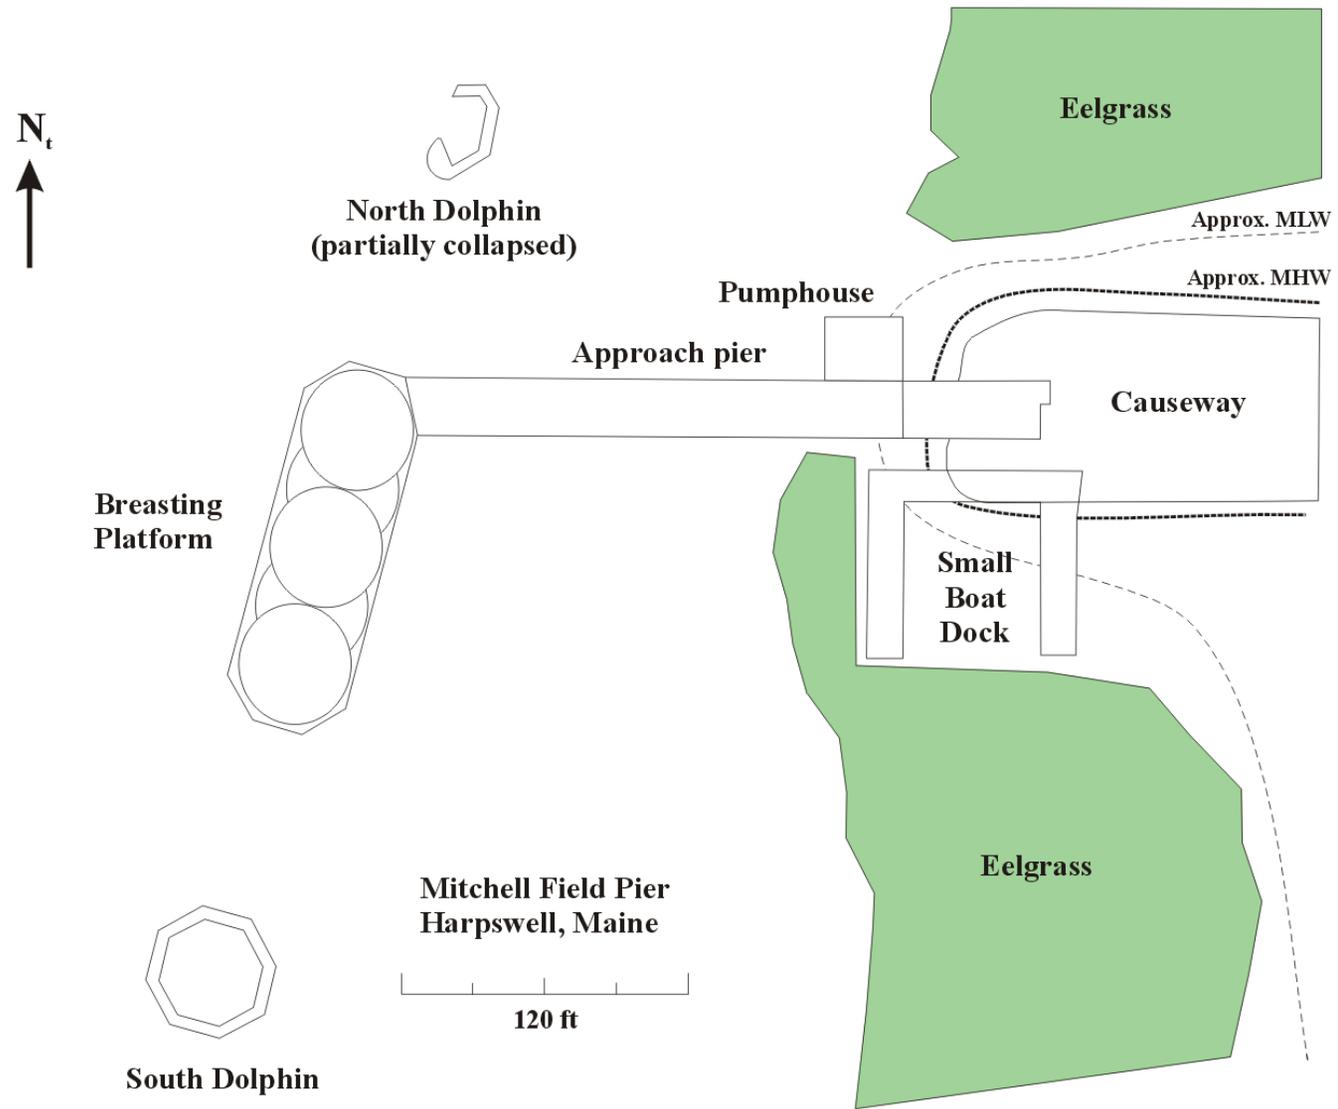
**Figure 2. Pier structures and eelgrass, *Zostera marina*, delineation**

Although not part of the current project, a survey and delineation of the eelgrass, *Zostera marina*, meadows that exist on either side of the causeway leading to the Approach Pier was performed on July 27, 2011 as part of the habitat assessment conducted for the proposed boat launch facility at Mitchell Field (see Figure 2). South of the causeway the eelgrass meadow forms a band between 140 feet to 165 feet wide, narrowing to approximately 28 feet adjacent to the western wall of the boat slip. North of the causeway the meadow is approximately 190 to 210 feet wide. The seabed in this area is coarser and the meadow is interrupted by areas of exposed bedrock (ledge); an interruption of the meadow also occurs in the vicinity of the Approach Pier resulting from shading by the pier.
