Mitchell Field Navy Facility Tank 100,000 Gallon Elevated Tank Condition Assessment Report

Town of Harpswell, ME

Assessment Performed July 1, 2014

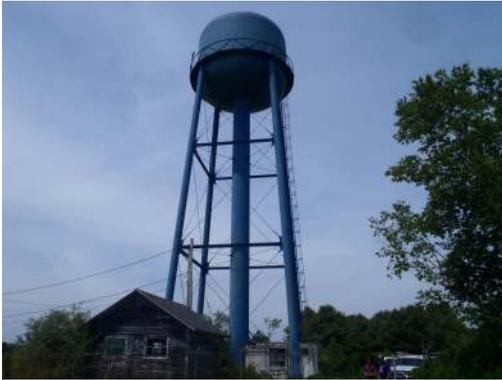
Overall view of the 100KG Mitchell Field elevated tank.

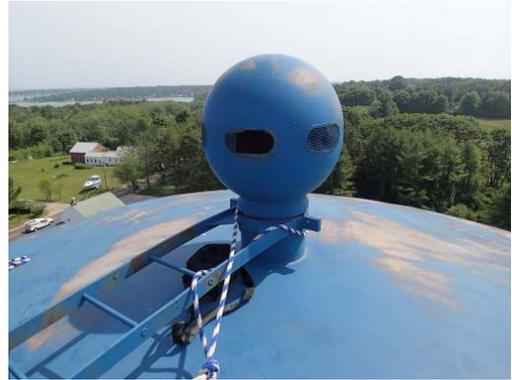
Roof finial ball has six 9"x4" oval vent screens, two of which have large holes.

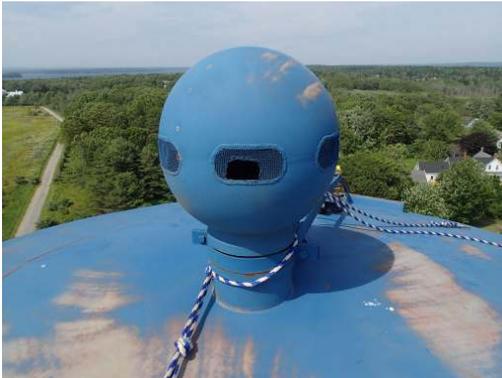
Showing a hole in the finial ball screen.

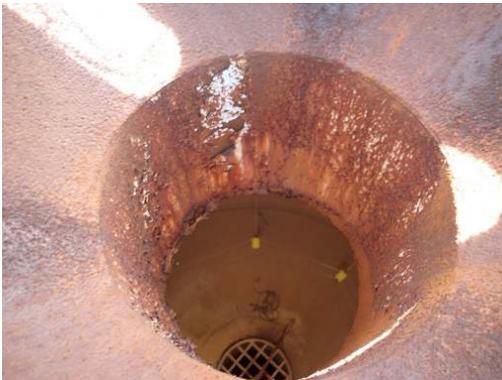
Showing corrosion on the interior of the finial ball which is open to the tank interior

1. Given the degree of existing corrosion and potential for metal fatigue currently taking place along the stub to roof junction and the outdated design of the vent itself, it is recommended that the vent assembly be replaced in its entirety with a new aluminum vacuum/pressure relief assembly with equal or greater airflow characteristics during the next tank maintenance operations.

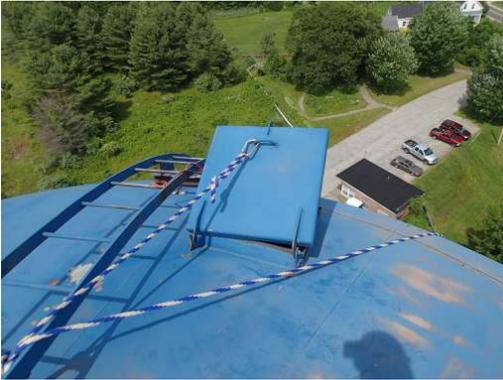
The hinges on the single 24"x24" hatch cover are broken

2. The overflow pipe opening should be equipped with a screen and flapper assembly.
3. The roof hatch cover hinges were found to be in poor condition with one broken at the welded connection to the roof and the other severely bent and damaged. The cover was removed to ground level during this inspection but should be replaced if this tank is to be returned to active service.

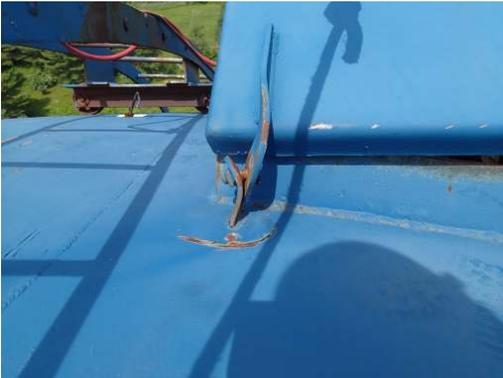
The second hinge is bent and twisted

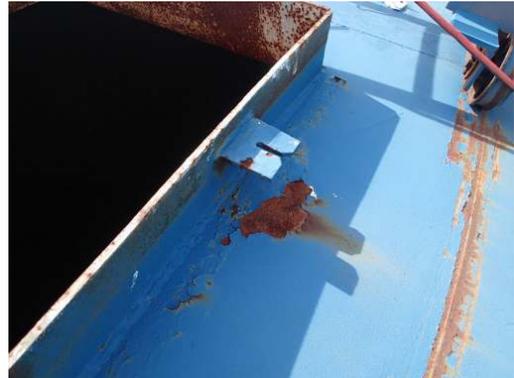
Showing a lock hasp present on the hatch neck but there was no lock

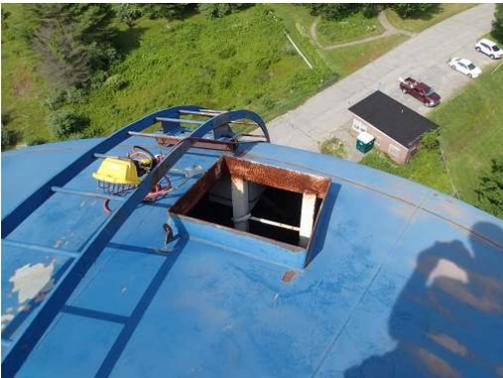
The hatch cover was removed for safety reasons due to poor structural integrity of the hinges

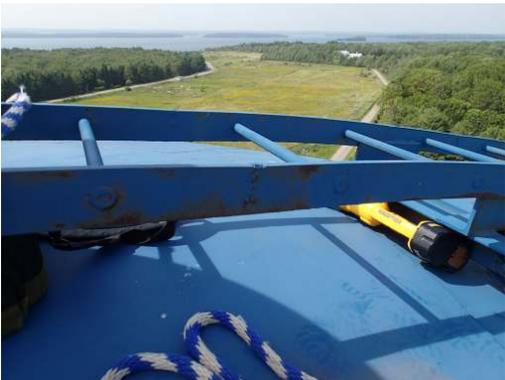
Showing corrosion of the roof ladder side rails.

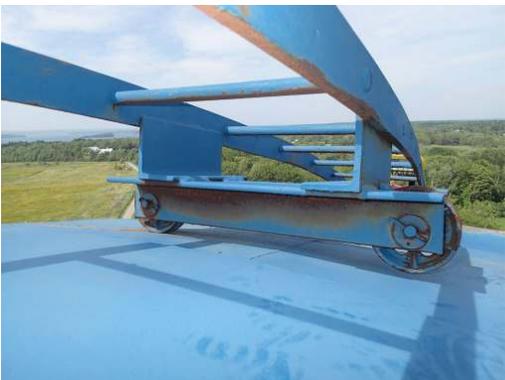
Shows medium grade corrosion on the underside of the ladder and wheel assembly.

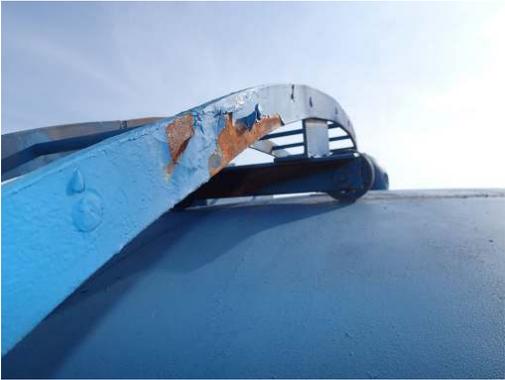
Shows medium grade corrosion where the coating has delaminated from the roof ladder siderails

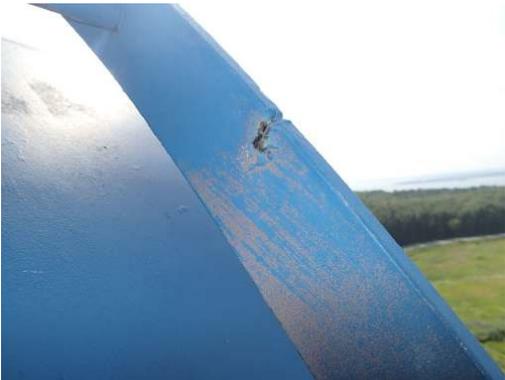
Showing a notch in the roof ladder side rail to allow for proper fit to curvature of the roof siderails

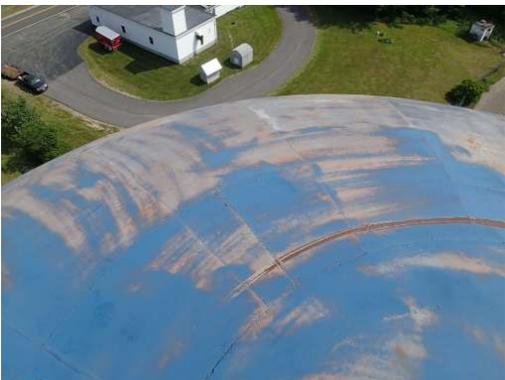
The exterior roof is in fair to poor condition with heavy weathering revealing the underlying coatings.

All exterior surfaces should be abrasive blast cleaned to an SSPS-SP#6 Commercial blast grade. The exterior surfaces should then be re-coated with a zinc/epoxy/urethane coating system. This coating system should be comprised of (1) coat of a moisture cured zinc rich

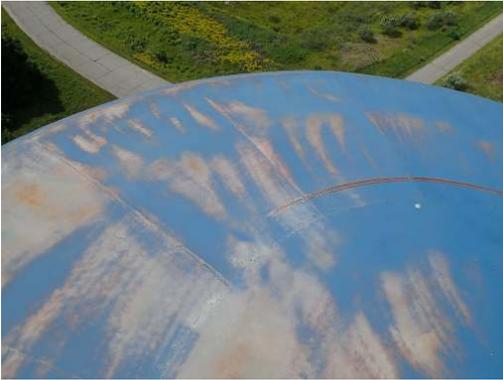
Light rust and severe weathering was observed throughout the roof plates

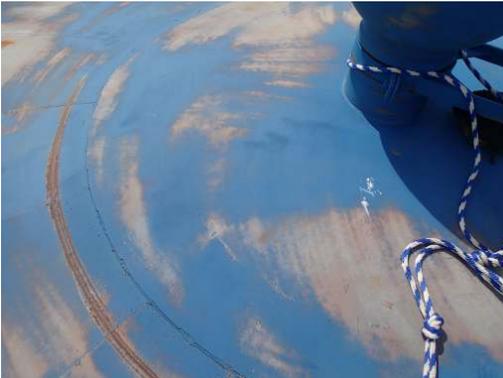
Showing weathering and abrasion damage along the center roof area

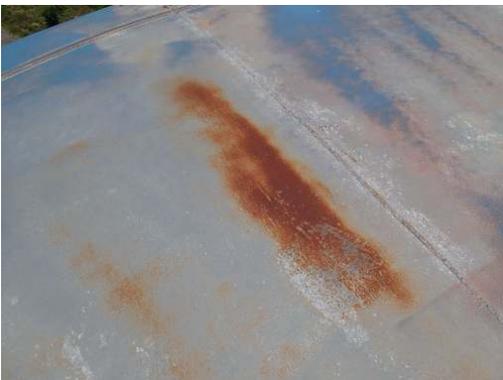
Shows light rust breaking through the coatings on the roof

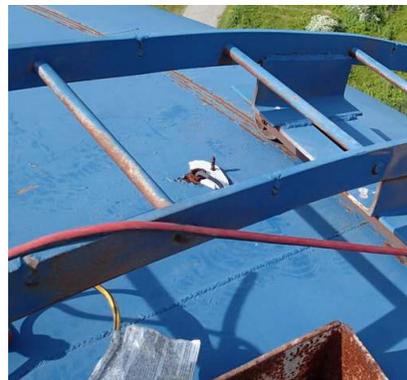
There is an open hole in the roof for wiring that should be sealed if the tank is returned to service

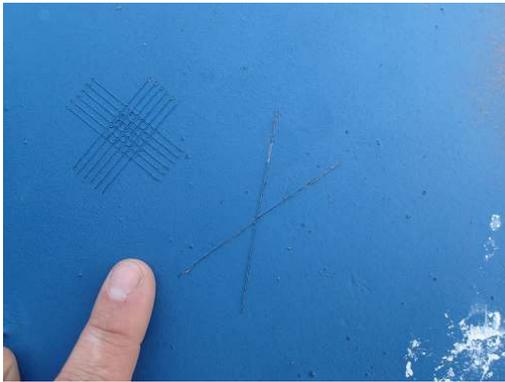
Shows adhesion testing on roof surfaces indicating generally sound interfacial adhesion

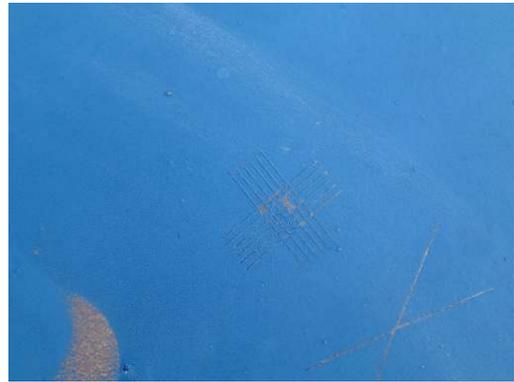
Shows adhesion testing on roof surfaces indicating generally fair interfacial adhesion

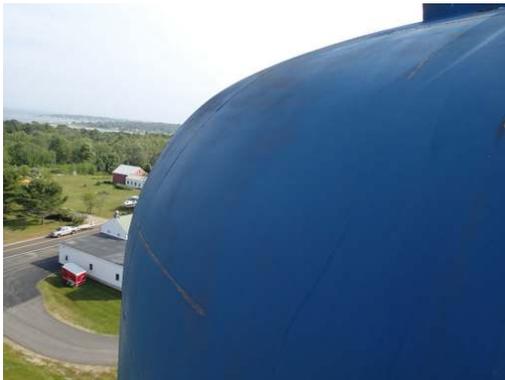
The coatings on the roof knuckle are weathered and there is evidence of abrasion damage from the revolving ladder

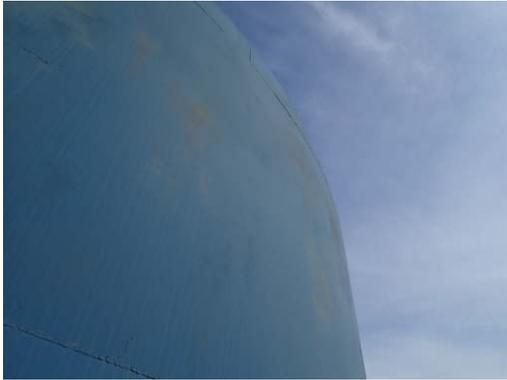
Shows light rust and soiling present on the shell plates

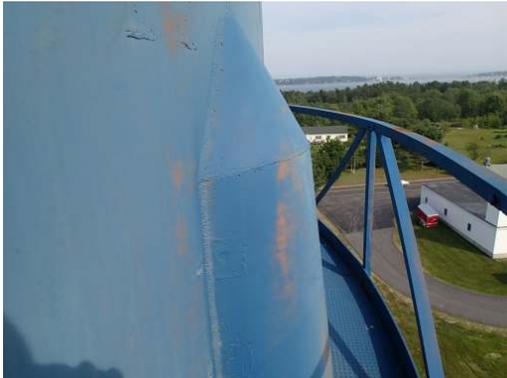
Showing top coat weathering on the shell and leg column post heads

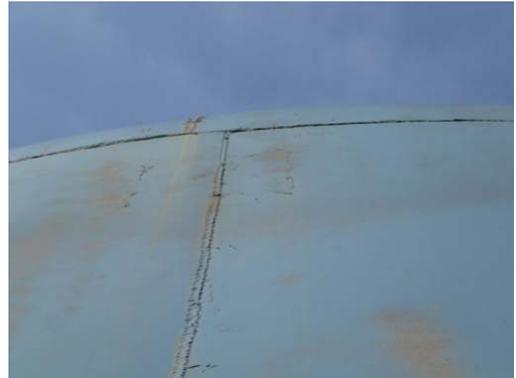
Shows what appears to be erection burrs adjacent to the shell plate weld seams

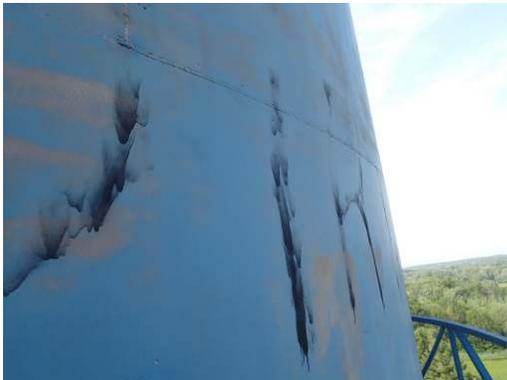
Showing graffiti on the exterior shell.

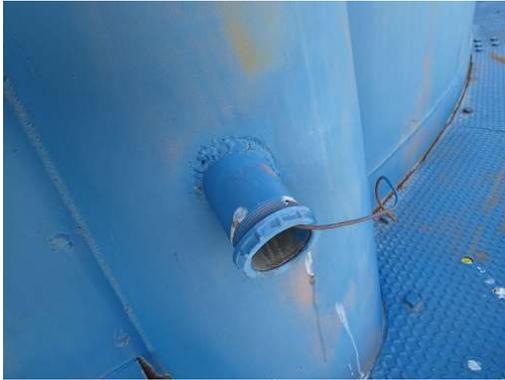
Showing wiring protruding from a pipe stub in the leg column post head at the balcony level

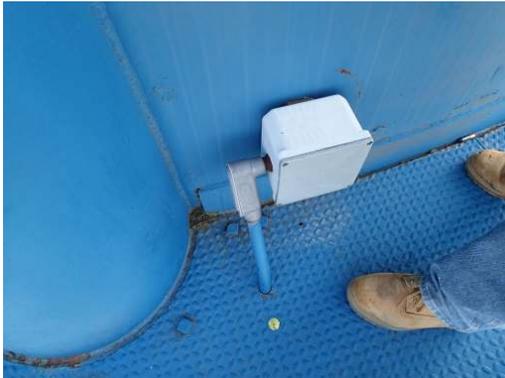
Showing a junction box and associated conduit for cathodic wiring at the balcony level.

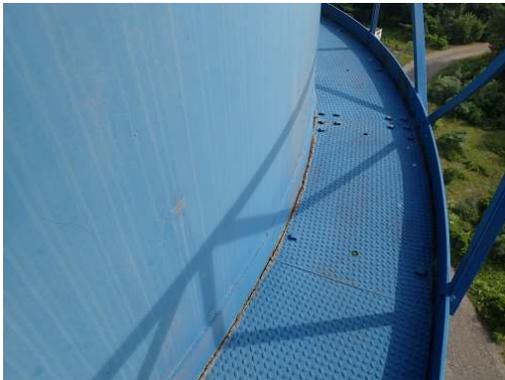
The balcony walkway are in generally good condition except for heavy corrosion along the edges.

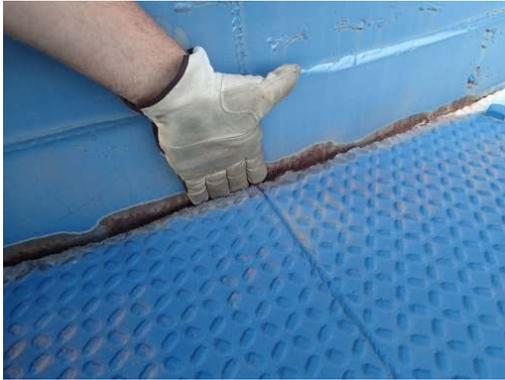
Showing a gap at the shell to balcony junction with heavy rust on the shell plate

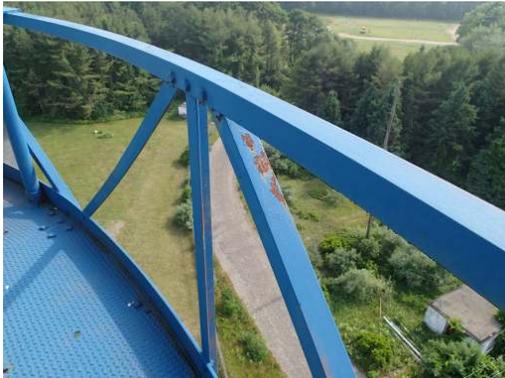
Shows scattered areas of coating failure and corrosion on the handrails.

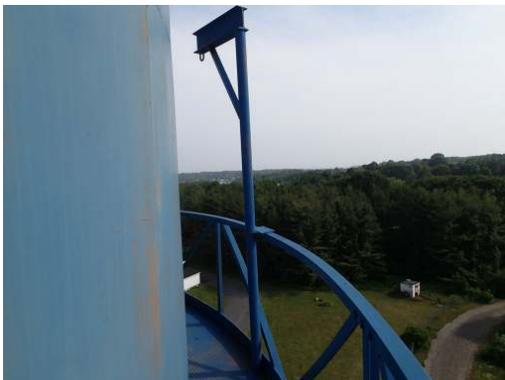
Shows a davit assembly secured to the balcony handrail

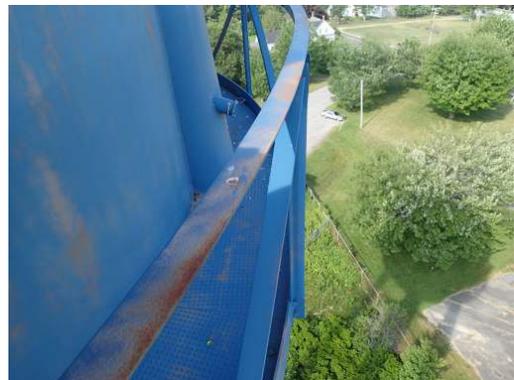
Shows an area of significant light to medium grade rust on the balcony handrail

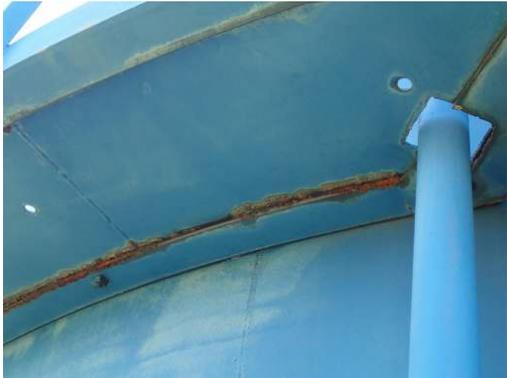
Showing corrosion along the underside of the balcony walkway at the junction with what appears to be a supporting angle

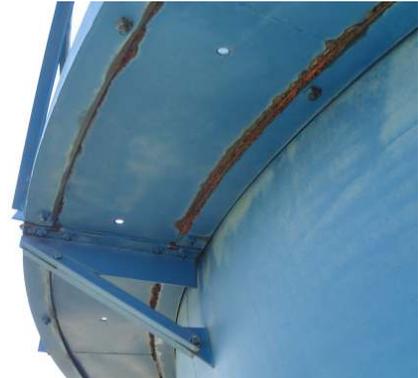
Showing corrosion and at least slight to moderate metal loss along the underside of the balcony.

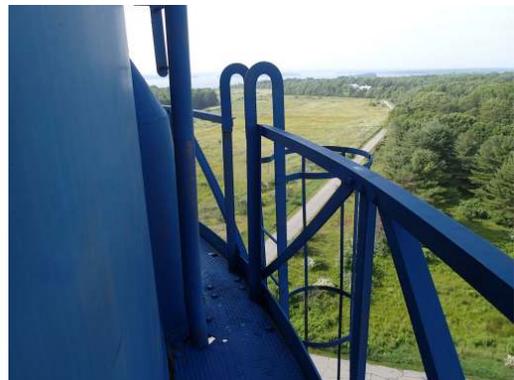
Shows a pass through in the balcony handrail which allows for access onto the balcony

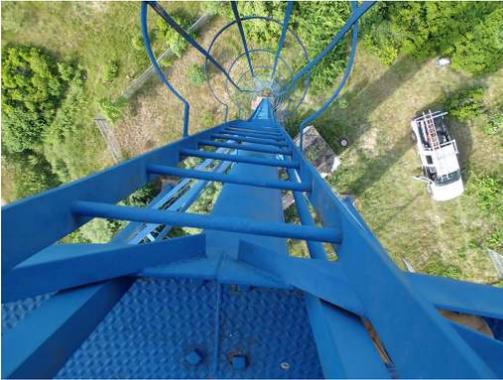
The leg column access ladder appears in sound structural condition with no obvious deficiencies observed

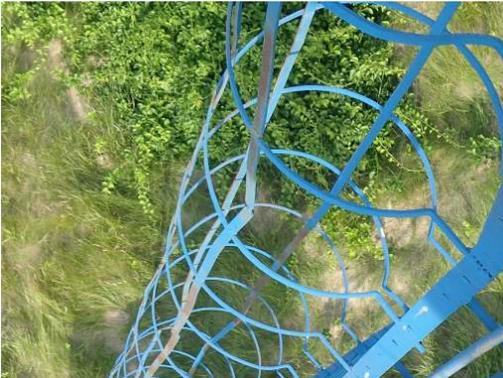
Several of the vertical ribs of the ladder cage are bent which has compromised the welds at several locations

7. The riser foundation is in poor condition and should be resurfaced to prevent additional degradation.
8. There are several ladder cage straps that are severely bent from an unknown external force. At least one of the straps is no longer welded to the adjoining strap and therefore requires welding repairs to be performed.

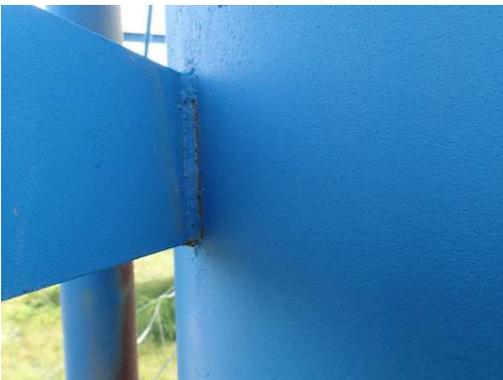
Light rust on the weld seams of several ladder to leg column brackets does not appear to be affecting the structural integrity

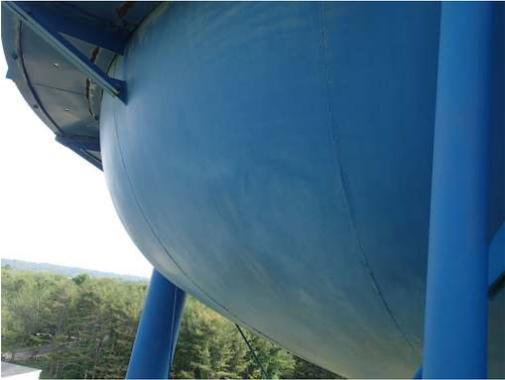
The bowl surfaces visible from the access ladder are weathered but exhibit little corrosion

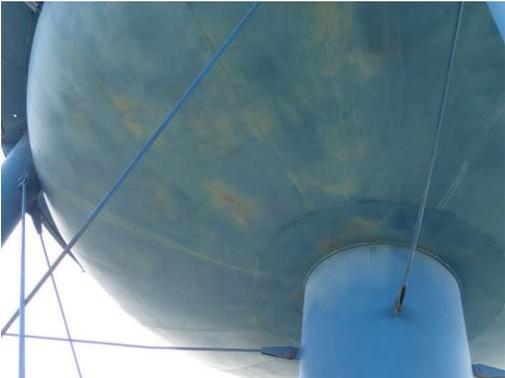
Shows significant weathered coating and scattered areas of light rust on the bowl surfaces

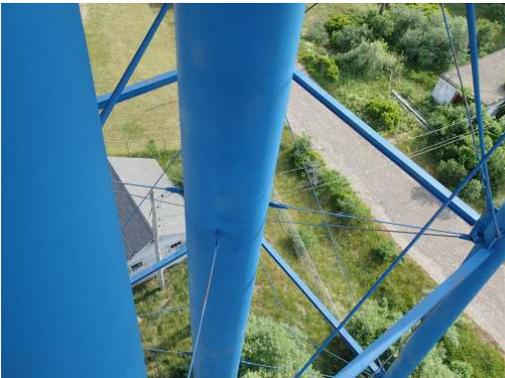
Shows an overall view of the riser and associated radial rods

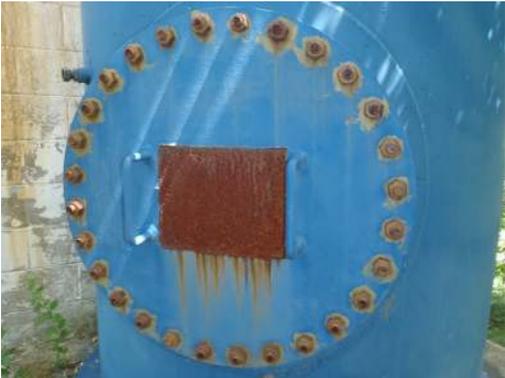
Corrosion is present on all bolted connections as well as where the tank ID plate was originally attached

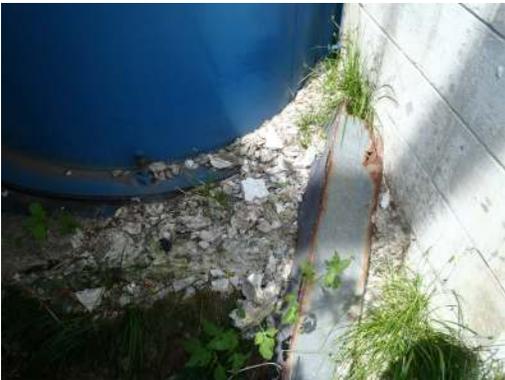
Shows the base of the riser adjacent to a concrete block building

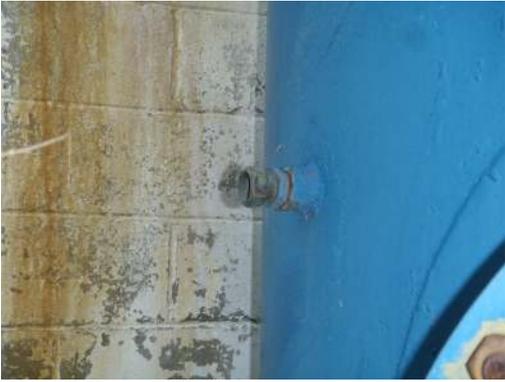
There is an unused penetration in the side of the riser adjacent to the hatch

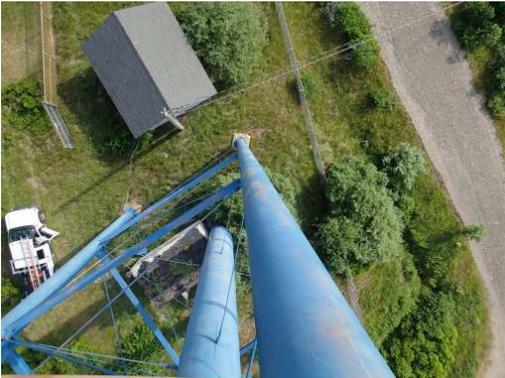
Shows significant weathering on the leg columns

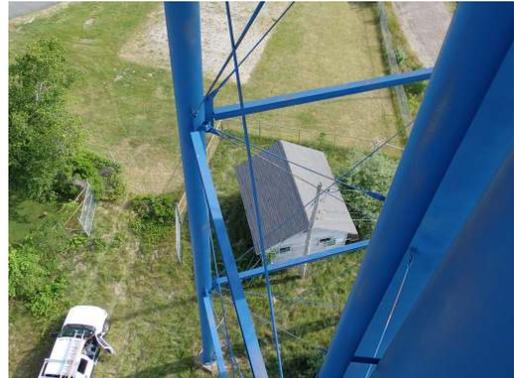
Shows the sway rod and strut connections to the leg columns to be in good condition

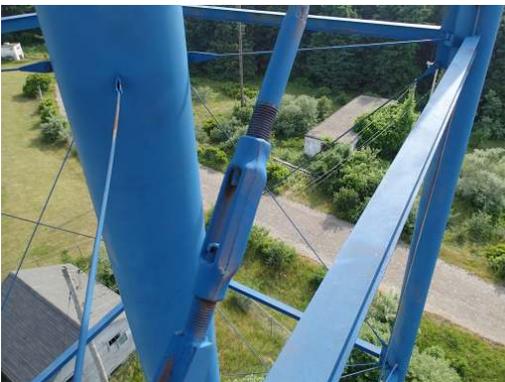
The sway rod turnbuckles are experiencing light rust but appear in good structural condition.

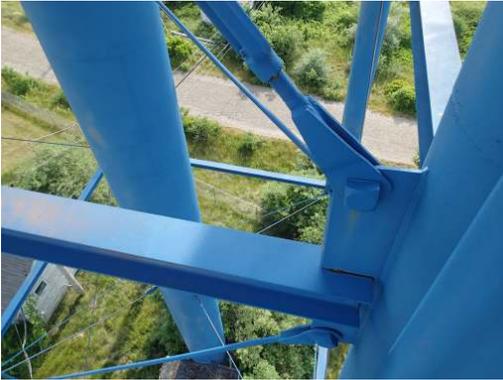
Showing localized areas of light rust on various connections to the support structure

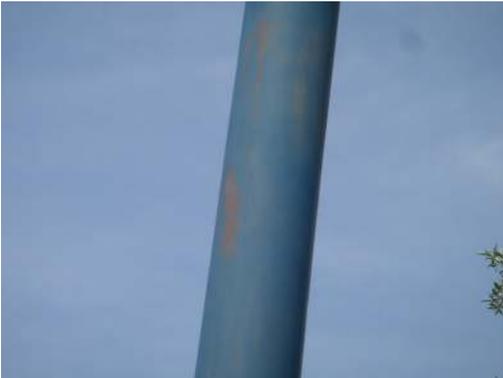
Shows the coatings on the leg columns to be weathered but there is little corrosion

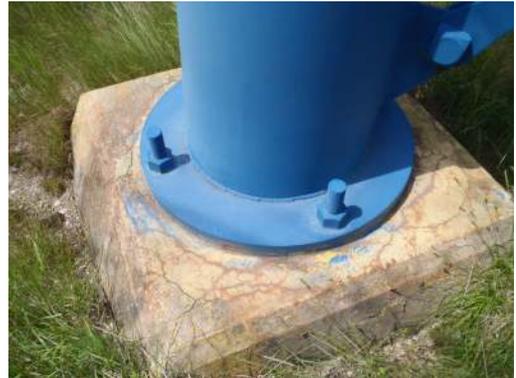
The leg column base plates appear in sound structural condition with no significant coating degradation observed

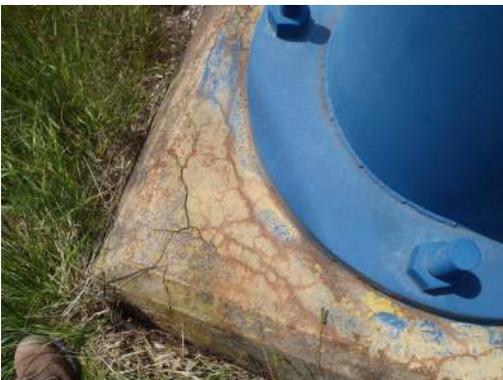
Shows what appears to be surface cracking in one of the leg column footings

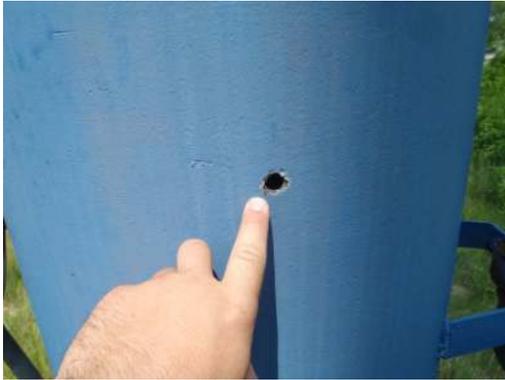
There is an ~3/4"Ø hole in the base of the leg column that supports the overflow pipe

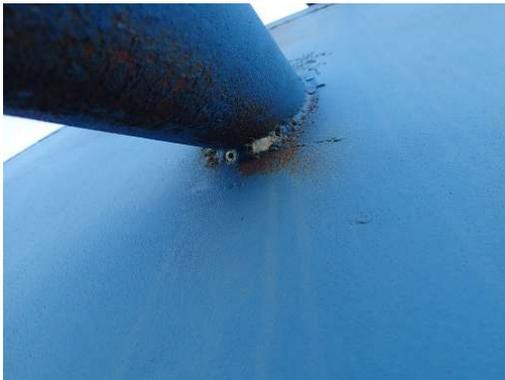
Showing corrosion on the underside of the overflow pipe and adjacent shell surfaces.

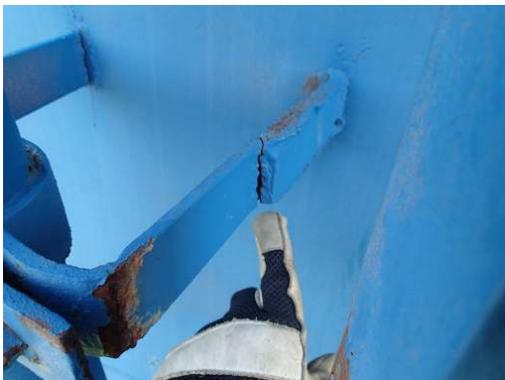
Showing a crack on the overflow pipe standoff bracket at the balcony level

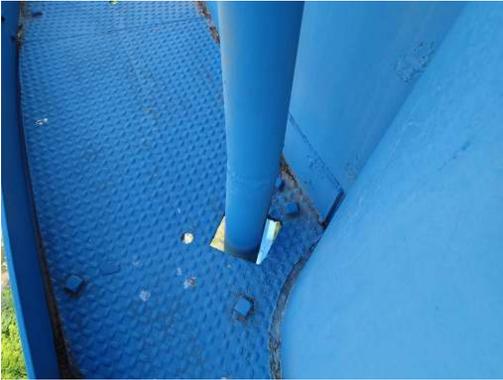
Showing where the overflow pipe penetrates the balcony.

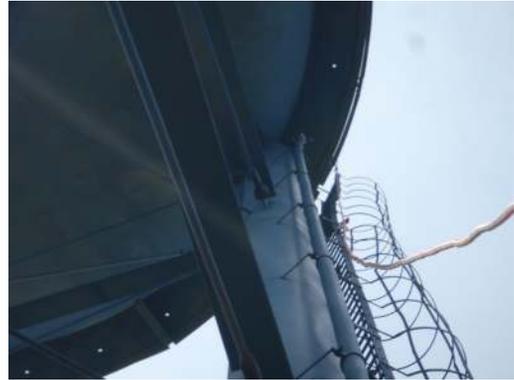
The overflow pipe is supported at multiple levels on the leg column

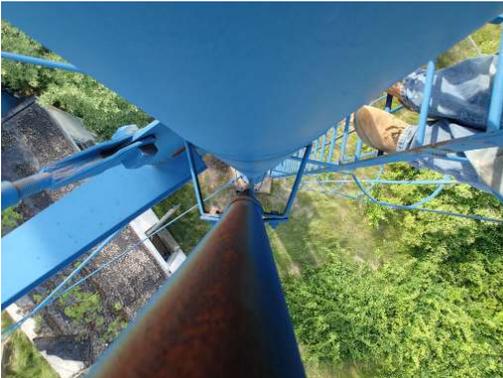
Showing corrosion occurring on the backside of the overflow pipe.

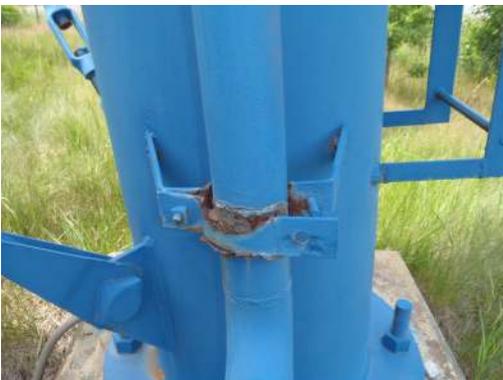
Shows heavy rust, scale and associated moderate metal loss as well as a missing nut on the lower overflow bracket

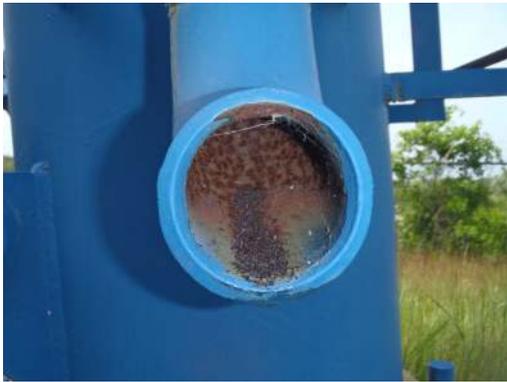
The overflow pipe is not equipped with a screen or flapper assembly

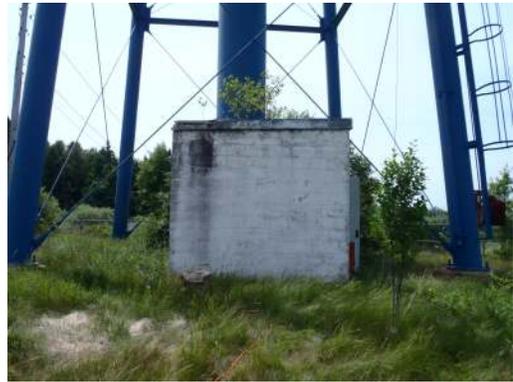
Shows a concrete block wall building under the tank and adjacent to the riser pipe

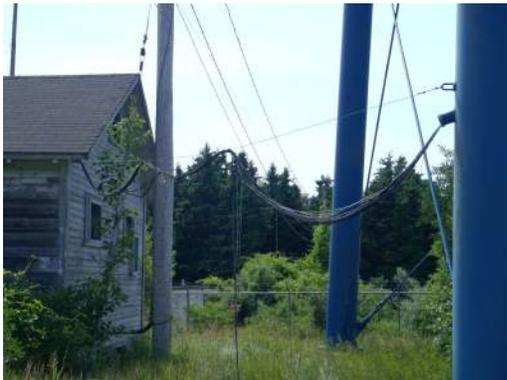
Shows wiring spanning from a wood framed building to an adjacent leg column

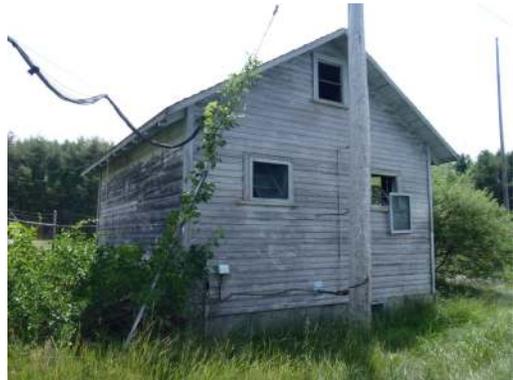
Shows a wood building adjacent to the tank

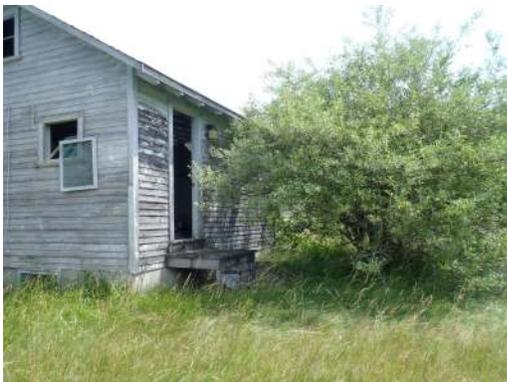
The building appears to be run down and no longer in use and there is significant vegetation growth nearby

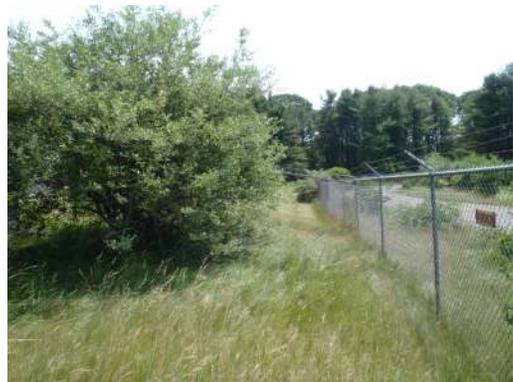
The perimeter fence surrounding the tank site appears in sound condition

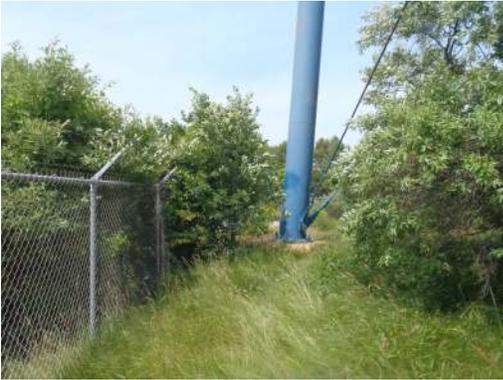
There is a heavy growth of trees/shrubs and grass both inside and outside of the perimeter fence

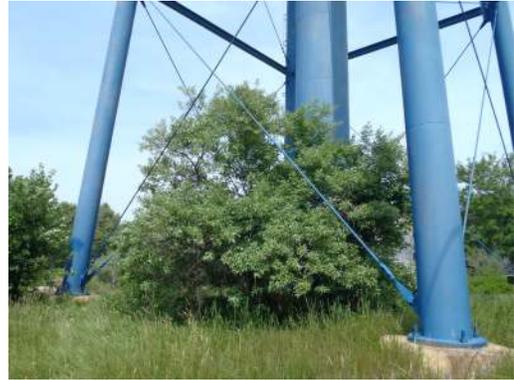
Shows large tree/shrub present under the tank

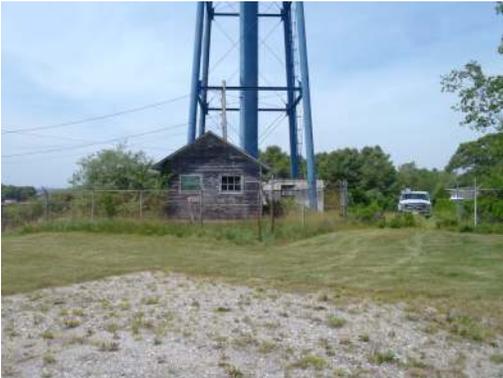
Shows the perimeter fence and access gate surrounding the tank site

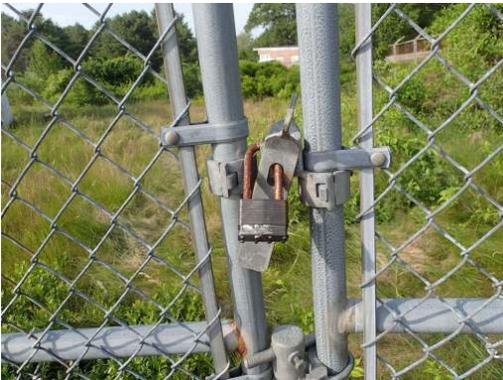
The access gate is equipped with a lock.

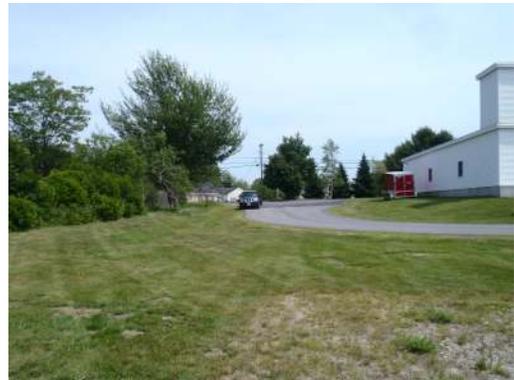
Shows the close proximity of an access road and building to the tank

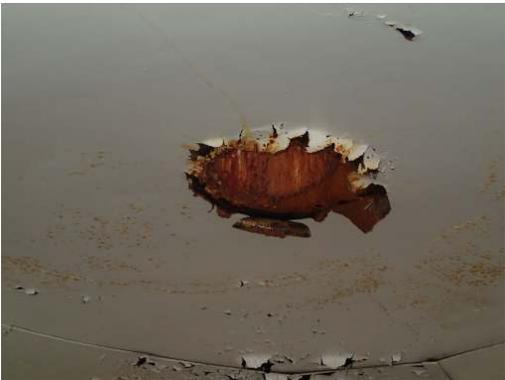
Delamination was noted along the center roof as seen near the vent opening.

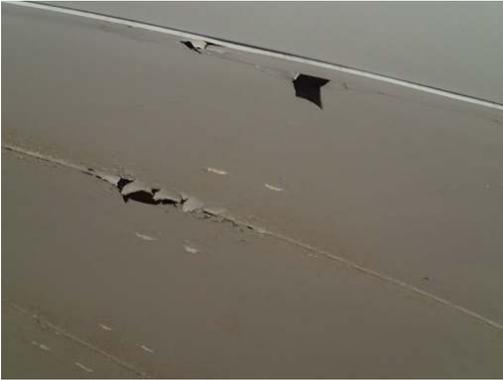
Showing delamination and corrosion along the roof plates and seams.

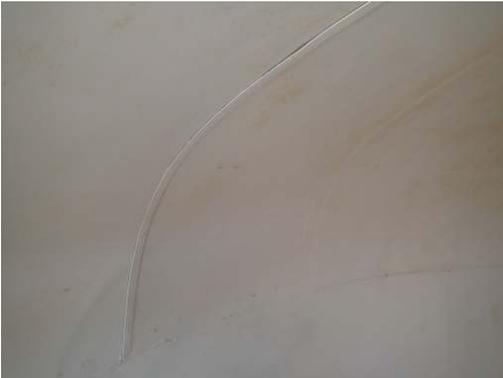
Shows backing strip in place on the underside of the roof and knuckle plates

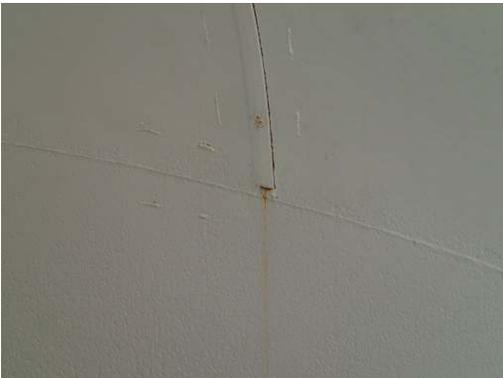
Shows corrosion under the backing straps along the roof and knuckle plates

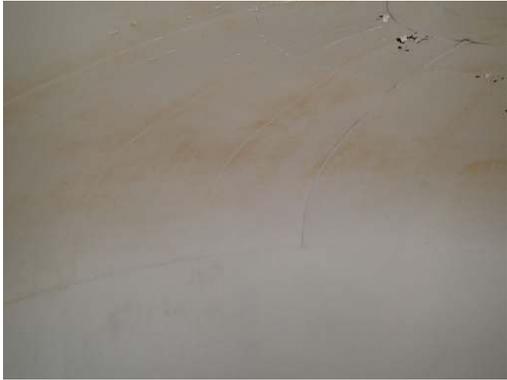
The roof appears in sound condition with no metal loss or open penetrations noted.

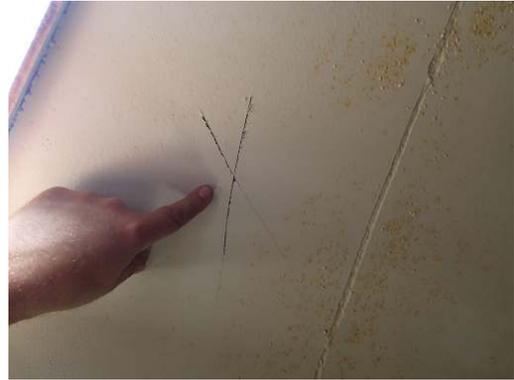
Showing an adhesion test performed on the underside of the roof indicating generally good adhesion

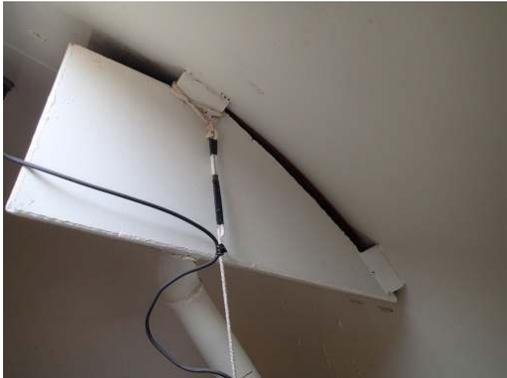
Sideview of the weir box configuration showing the box is stepped off of the roof and supported by gusset plates only with no access for painting

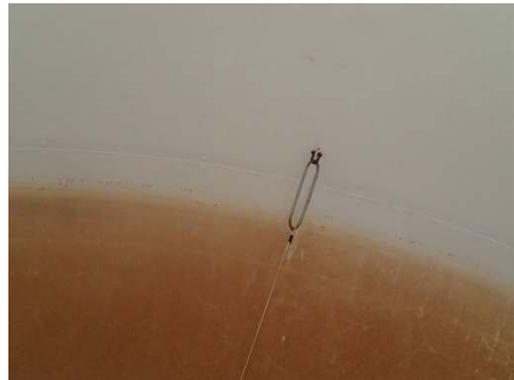
Showing rigging points for the cathodic protection system on the interior shell.

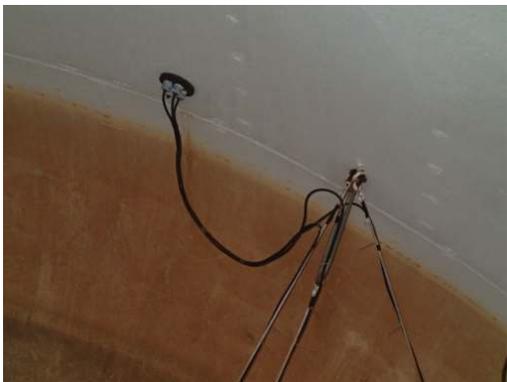
Showing cathodic equipment on the interior shell.

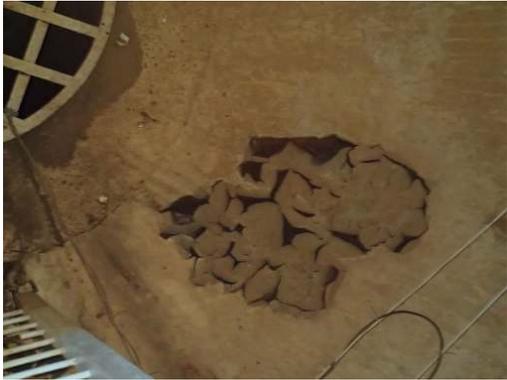
Showing an area of coating delamination and corrosion on the interior bowl.

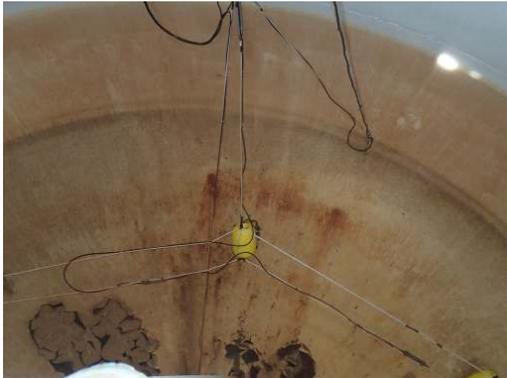
View of the floating cathodic system.

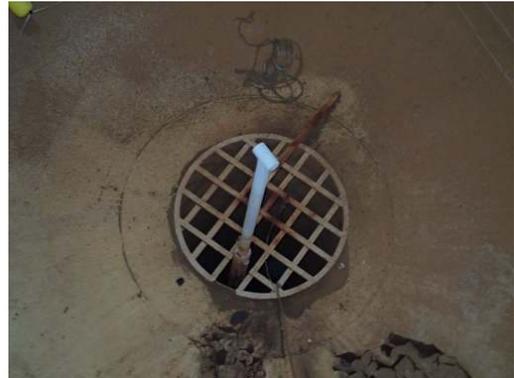
The top of the riser is equipped with a grate thru which a circulation line penetrates

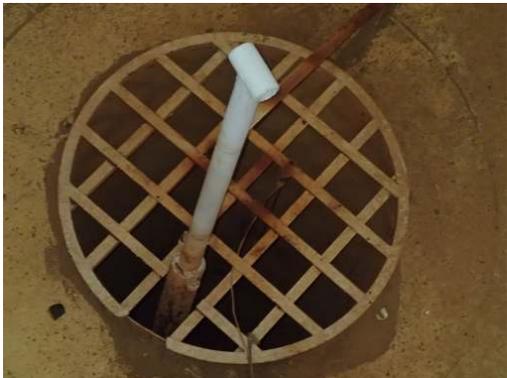
The riser grate and circulation line appear intact

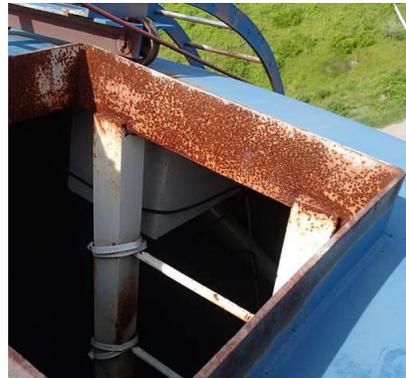
The weld integrity at the top of the interior ladder is questionable and should be reinforced

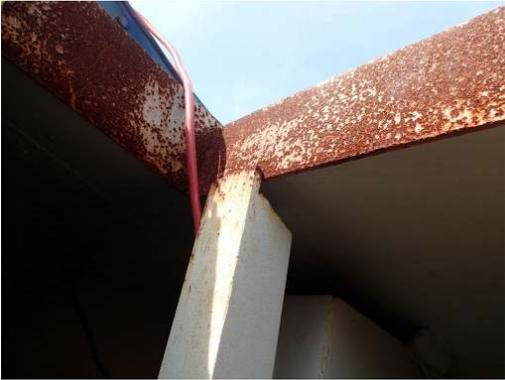
The interior ladder siderails connections to the manhole neck should be extended and reinforced during future maintenance

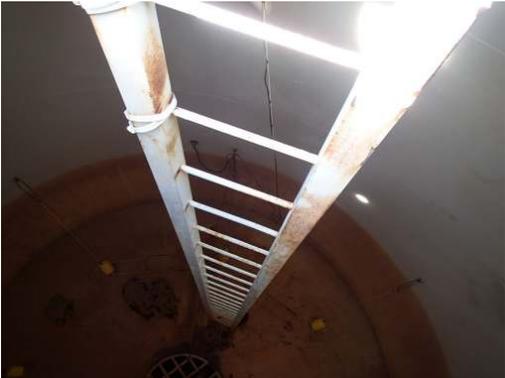
The interior ladder appears in sound structural sound condition but there is significant corrosion along the rungs and rails. There are no mid point stabilizers.

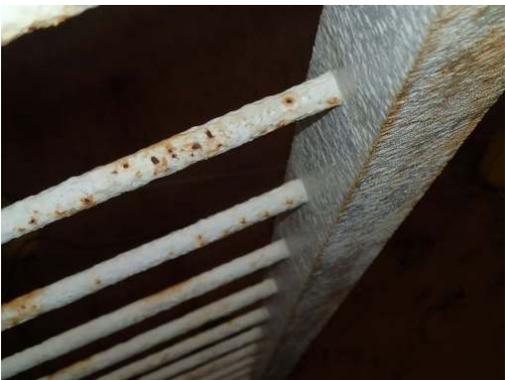
Closeup of corrosion and past metal loss on the interior ladder.
